Rainfall-induced collapse of old railway embankments in Norway

Heyerdahl H., Høydal Ø., Nadim F., Kalsnes B.G.
Norwegian Geotechnical Institute

Børsting T.
Norwegian National Rail Administration

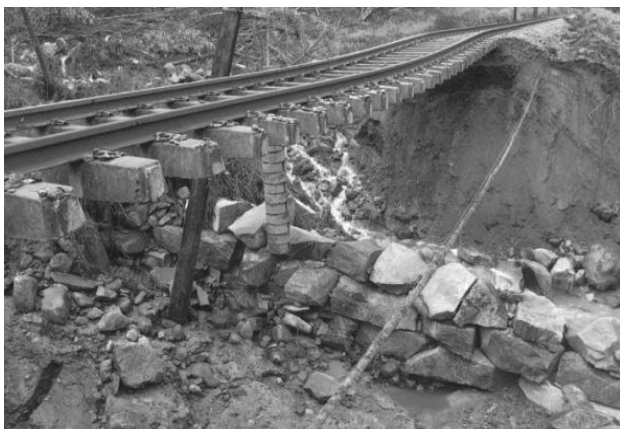
In 2011 damage was frequently caused by flash floods following intense short-duration rainfall. High discharge may result in upstream damming of water due to the culvert being unable to transport the discharge from the catchment, unless the water finds alternative ways underneath or through the embankment (which in turn destabilized several embankments constructed of sand during the same period). Damming of water will increase pore-water pressures in the embankment and lead to collapse of a construction which needs drained conditions to remain stable. Overtopping of embankments is particularly disastrous, especially for embankments constructed of materials that are easily eroded, as sand and silt. Embankments may experience rapid and total destruction under such conditions. A photo showing an example of complete destruction of the embankment around a culvert is shown in Fig. 1. Note that the embankment is mainly constructed of relatively fine, sandy soil.

Figure 1. Example of total destruction of embankment around culvert near Ål, Bergensbanen railway line (Oslo to Bergen).

Improved maintenance, redesign and reconstruction of culverts may reduce problems in the future. However, the high number of culverts lines (tens of thousands) indicates that similar collapses of embankments may still be a problem in the future. Improved design of culverts with built-in safeguards (increased cross section, double pipelines etc.) is possible, but costly judged from normal maintenance budgets. Modernization normally is restricted to already known problem areas. This will keep existing culverts mainly unaltered and still contributing to a high future risk.

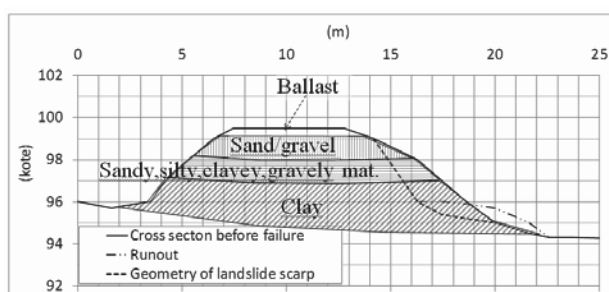
A slope failure at a railway embankment at Tomter occurred on 23rd December 2011. The line was not physically cut off, but train traffic was stopped until inspection by geotechnicians from NGI was made the following day. A cross section is shown in Fig. 2. Field survey was somewhat hindered by low temperatures and a thin frozen crust that had developed through the preceding night. It was found that the embankment consisted of a bottom layer of clay on top of the natural terrain (marine clay), followed by a layer with high sand and silt content. Above this layer there was a 1 m thick layer of sand and gravel, added in a general uplift of the track around 1950-60, and at the top crushed rock ballast. In spite of the elevation above the surrounding terrain, the sandy/silty layer was observed to be very moist, and appeared almost liquefied. The water content w of a bag sample was measured to 17.5 %. In situ saturation rate of the sandy/silty layer may not be determined from a bag sample (in situ density is unknown and water is lost during sampling), but this indicates that the sandy/silty layer may in fact have been close to full saturation prior to the slope failure.

Figure 2. Cross section of failed embankment at Tomter, Østfold county railway line. Geometry of slope failure 23rd December 2011 is indicated. Natural soil below embankment is marine clay.

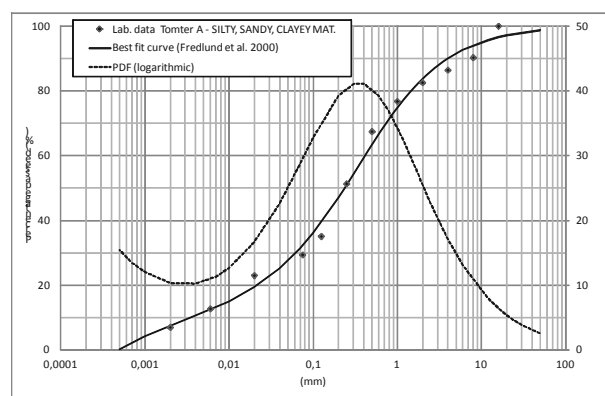
Results from grain size distribution (GSD) analysis of the sample are summarized in Table 1 and Fig. 3. The moist layer described in field as a sandy/silty layer is characterized as sandy, silty, gravelly and clayey material, according to terminology and grain size limits defined in Norwegian Geotechnical Association (1982). The soil is well graded.

differentiating the GSD-curve. The PDF will correctly represent the most frequent particle size when first taking the logarithm of the particle size, see Eq. 2 (Fredlund et al. 2000), in which $P_f(D)$ is the logarithmic PDF. For the analyzed sample the most frequent particle sizes are found in the sandy fraction, with a peak at 0.3-0.4 mm. This corresponds with the laboratory description of the soil, where the first adjective (“sandy”) nominates the largest mass fraction.

Figure 3. Results from laboratory GSD analysis, empirical GSD function and logarithmic PDF (Fredlund et al. 2000).

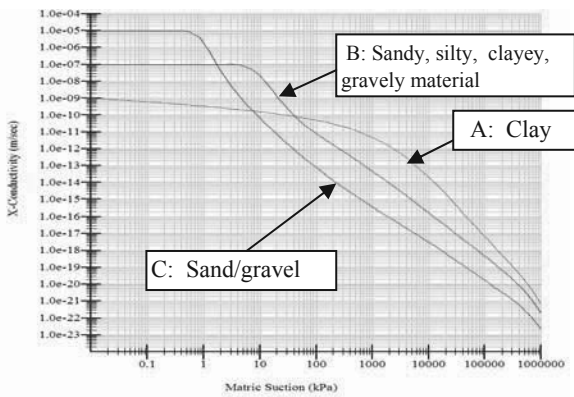
The hydraulic conductivity curves show the well-known effect that less permeable clay (when saturated) is more permeable than coarse-grained soils for high matric suction.

Figure 4. Hydraulic conductivity curves used in seepage analysis for layers A, B and C.

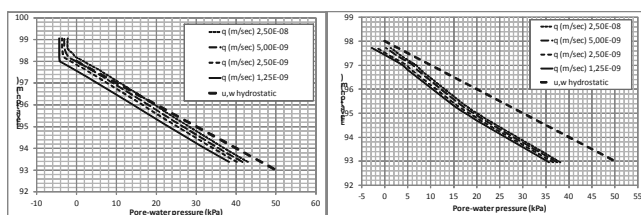
To get an idea of the range of pore-water pressures resulting from infiltration seepage analyses were made for varying values of constant infiltration. Annual rainfall in the region corresponds to ca. 2.5E-08 m/sec, ~800 mm/year (Norwegian Meteorological Institute 2011). Runoff will result in infiltration being smaller than the rainfall. Constant infiltration on the surfaces of the embankment has been varied between 1.25E-09 and 2.5e-08 m/sec. Results are shown in Fig. 5 for two profiles, one at the centre and one at the edge of the embankment. Applied infiltration rates are equal on top of the embankment and on the slopes. Subsequent analyses reducing infiltration rates on the slopes did not result in substantially different results. Seepage boundaries are used to find the extension of seepage zones at the bottom of the slopes. From the seepage analyses, it appears that even low infiltration rates produce positive pore-water pressures in layers A and B. The pore-water pressures at P1 at the centre of the embankment vary between 80 and 90 % of hydrostatic pore-water pressure for the chosen range of infiltration rates. For P2 at the edge of the embankment the pore-water pressures vary between 70 and 75 % of hydrostatic pore-water pressure.

Figure 6. Calculated and hydrostatic pore-water pressure vs. depth for profile P1 (left) and P2 (right) as indicated in Fig. 5.
