# Investigation of Reinforced Earth Structures Following the 2011 Tohoku Earthquake

Otani Y., Takao K.  
Hirose & co., Ltd.

**ABSTRACT:** An investigation of mechanically stabilized earth (MSE) structures constructed with Reinforced Earth (Terre Armée) technology<sup>1</sup> was carried out after the 2011 Tohoku Earthquake in Japan. Reinforced Earth walls examined for the survey were ranked according to associated disaster-caused damages. The results of this research indicated high levels of earthquake resistance in the steel-reinforced structures constructed with this technology method.

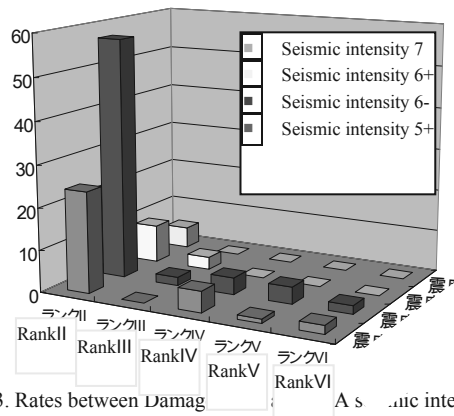
Figure 3. Rates between Damage Rank and Seismic intensity

As shown in Figures 3 and 4, the Damage Rank VI walls were at sites that were hit by upper intensity 5 to lower intensity 6 tremors, and in terms of their damage occurrence rates by wall height ( $5 \text{ m} \leq H < 10 \text{ m}$ ,  $10 \text{ m} \leq H < 15 \text{ m}$ ). They represent the same 0.4% rate in each seismic intensity and wall height. Therefore, the high degree of damage was not necessarily as a result of the strongest tremors or tallest wall heights.

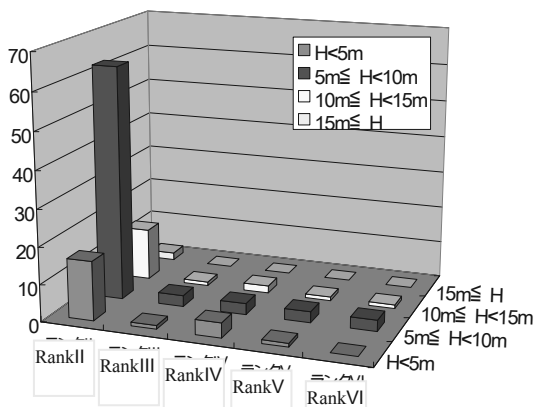
Figure 4. Relationship between Damage Rank and Wall height

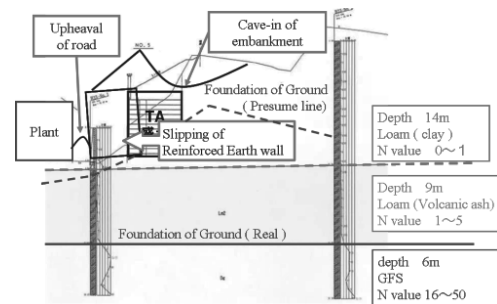
Along the boundary of a manufacturing site located in an area hit by lower intensity 6 tremors, a wall slipped forward by up to 7.0 m, accompanied by the uplift of the ground in front (by 3.0 m) and the subsidence of the embankment at its back (Photo 4). The structural integrity of the wall itself was confirmed through a strength test on the steel reinforcements and panels, an in-situ pull-out test on the reinforcing strips and laboratory tests on the embankment fill. The presence of very soft foundation ground was confirmed as a result of the in-situ boring and SPT tests carried out after the earthquake (Figure 5); the entirety of the reinforced earth fill seems to have slipped forward due to general movement at depth with soil characteristics lower than assumed during the design stage. This mechanism of general sliding was confirmed by an analysis of safety rating carried out considering soil characteristics assumed to have been present at the time of the earthquake.

Figure 5. Result of boring survey

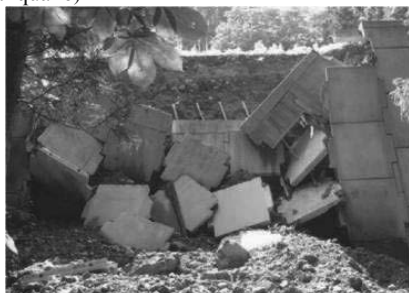
At a site where panels covering a Reinforced Earth wall deformed and collapsed (Photo 7) because of frost heave phenomenon while the structure was being constructed, part of the structure suffered further damage as a result of being hit by the 2008 Iwate-Miyagi Inland Earthquake, which registered a seismic intensity of upper 6. As a countermeasure against frost heave, it was decided to install a backside filter layer (non-susceptible to frost heave) and to substitute the existing earth fill with superior-quality earth fill (these measures are in accordance with the current standard<sup>1)</sup> for locations where deformation exists). While these measures were being implemented, the structure was subjected again to tremors from the 2011 Tohoku Earthquake, registering a seismic intensity of upper 5 at that location. The survey carried out this time revealed that sections of the wall where anti-frost heave measures were implemented, only rated Damage Rank I (Photo 8). On the other hand, sections where the measures had not yet been implemented resulted in Damage Rank VI (Photo 9). In the latter sections, it is likely that the connections between reinforcing strips and panels had already been damaged due to accumulated displacement brought about by prior frost heave.

Photo 9. Collapse of facing panels in the sections where no fill substitution had taken place (After the 2011 Tohoku Earthquake)
