Evaluation of diaphragm wall as-built data to determine the risk of leakage for the Kruisplein car park excavation in Rotterdam, The Netherlands

Hannink G.

Engineering Consultancy Division, City of Rotterdam, The Netherlands

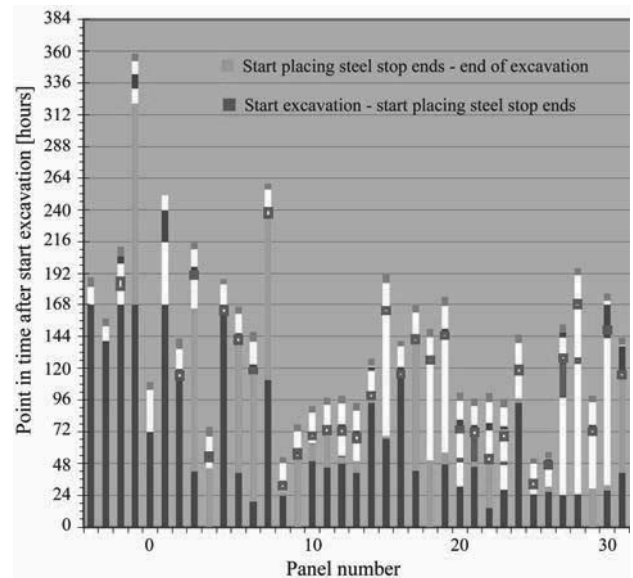
Long periods of elapsed time for a particular activity may indicate an increased risk of imperfections.

Figure 3. Continuity of the production process.

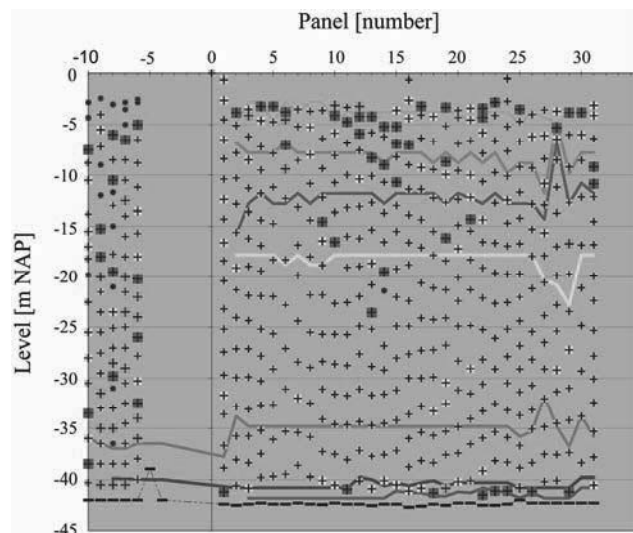
Figure 4 shows the calculated deviation of wall thickness as can be calculated from the concreting progress reports. From Figure 4 it can be identified where the panels are suspected to have a reduced thickness of more than 0.2 m. However, it is recommended to have more detailed information on the progress of the concreting process for future projects, as to increase the resolution (reliability) of this graph.

Figure 4. Deviation of panel width (data originating from leveling data and concrete consumption). The separation of the different soil layers as derived of excavation data and of geotechnical investigations is also indicated.

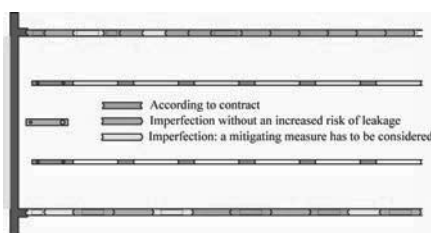
An overview of locations with an increased risk of leakage along the excavation circumference has been generated as shown in Figure 6.

Figure 6. Increased risk of leakage.

Subsequently, a number of mitigating measures has been defined for each individual panel as to compensate the increased risk. It appeared from the overall risk analysis that careful positioning of four ‘sleeping’ wells around the excavation would provide sufficient means for acting in case of leakage at any of the identified weak spots as shown in Figure 7. Additionally, for a number of panels it has been recommended to call for an intensified inspection and repair program (when necessary) during the excavation works.
