Managed remediation of a large Victorian gravity quay wall using the observational method

Turner M J, Smith N A
Applied Geotechnical Engineering, UK

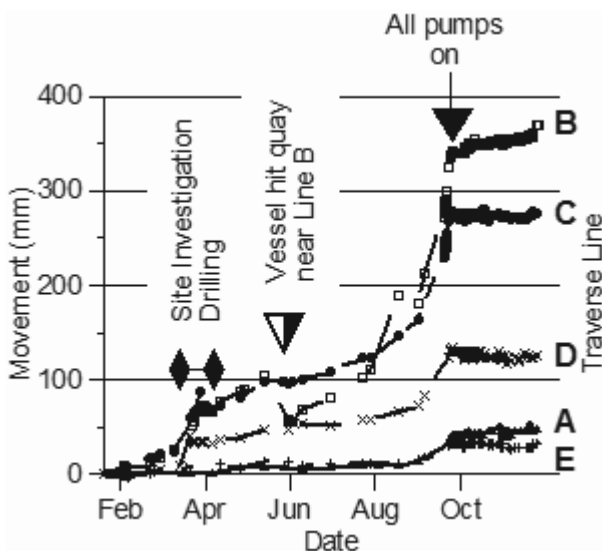
Figure 4. Crest movements during 2000.

The displacements of the quay wall measured at the traverse lines are illustrated on Figure 4. It can be seen that there was a noticeable effect upon outward wall displacements while the site investigation works were being undertaken in April 2000. Figure 4 also shows that the rate of outward movement also began to increase markedly in September of that year, and was accelerating. By September 2000 the worst affected area of the quay wall (Traverse Lines B and C on Figure 4) had recorded between 270 and 350mm of outward movement, relative to their

values in January of that year. At this time the analysis, design and procurement of the remedial works was still being progressed, but, based upon the evidence of the increased wall movements during the investigation work, contingency plans had already been put in place to deal with such a situation. Eleven dewatering wells were installed in a line behind the quay wall at approximately 10m centres, to lower the ground water level behind the wall. At that time the wall was moving forward by more than 10mm per day at the worst affected part, and was rocking measurably with the tide. The pumps were started as soon as the wells were connected, over a three day period, the first three being commissioned on 17 October and the balance by 19 October 2000.

As soon as the first pumps were started, the wall movement virtually ceased, as can be seen from Figure 4. Measurements eight days later showed that the amplitude of the rocking motion was less than half its magnitude prior to pumping. With the wall stabilised, work on installing permanent drainage and ground anchors could begin. The effects of the dewatering upon the groundwater levels behind the wall are illustrated on Figure 5.

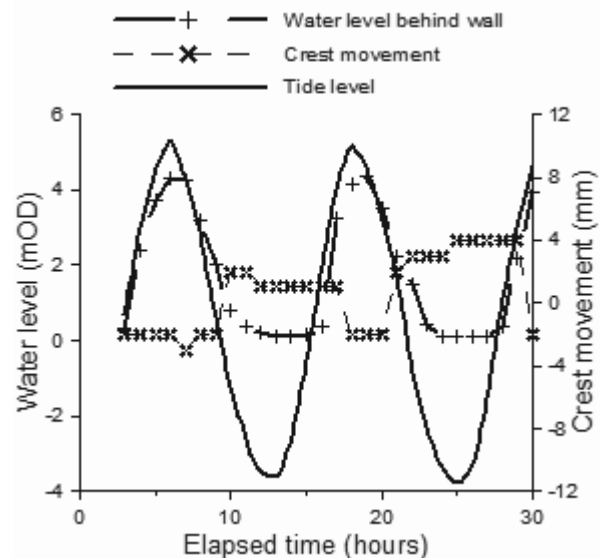
Figure 5. Water levels and crest movements 27-28 Oct 2000.

A feature of Figure 5 is that a distinct 'plateau' can be seen in the levels recorded for the water immediately behind the quay wall. The level of the retained water is drawn down to 0.0mOD by the pumping wells as the tide falls. It does not fall below this level, however, giving the step-like feature in the graph. The 0.0mOD level coincides with the invert level of the lower access-ways through the quay wall, which were open to the sea. When the tide was above 0.0m, on a falling tide, the retained water was clearly draining through these accessways, as well as being removed by the pumping wells. Once the tide fell below this level, then the pumping wells alone were removing the retained water, and, on the evidence of these readings, could only maintain the retained water at about the 0.0mOD level against the fresh water flowing from the landward side of the quay wall.

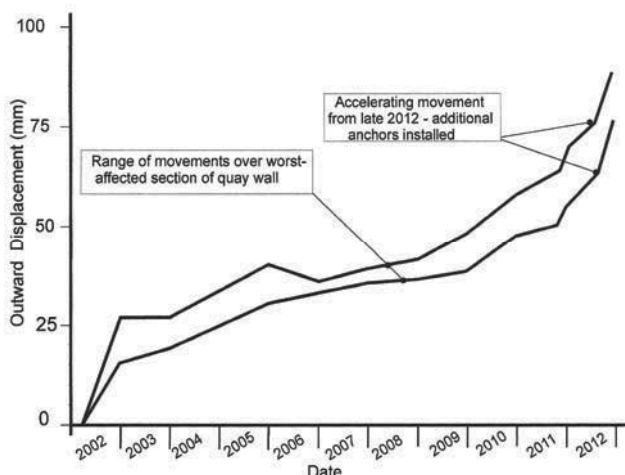
Figure 6. Wall displacements at crest level 2002 to 2012. (Toe displacements similar but generally smaller.)

Initial wall movements over the first 5-6 months were between 5 and 10mm at the crest and toe of the wall as the anchors took up further load. Load increases in the 43° anchors were typically between 50 and 200kN over this period.

By the end of 2002 the movements had stabilised at around 16 to 26mm at the crest, and 15 to 20mm at the toe. These data confirmed that the predominant mode of movement of the quay wall in the most active area was by sliding along a plane coincident with or close to the interface between the base of the wall and the underlying strata.

Over the next 3 years outward crest movements over the anchored section had increased to 30 to 40mm relative to the April 2002 readings and toe movements were between 35 and 40mm. Loads in the 43° anchors had increased by between 200 and 250kN. It had been planned to complete the main remediation works within this 3-year timeframe, but the monitoring works had demonstrated that movements were remaining controllable. The main works were put on hold, therefore and a watching brief was maintained on the wall. Based upon the previous readings, a movement criterion of 10mm/year had been adopted as a signal that further support works needed to be put in place.

By 2012, however, inclinometer and traverse line readings were indicating that outward wall movements were reaching 10 to 12mm per year, and the loads in the 43° anchors were increasing at an average of around 150 to 300kN per year. Additional interim measures were undertaken at the end of 2012, when a further six 1800kN capacity 43° anchors were installed through the face of the wall over the anchored section.

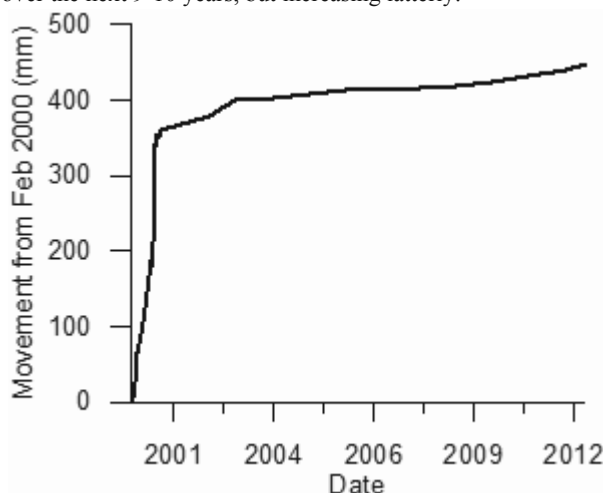
Figure 7 Wall crest movements between February 2000 and June 2012

For reference, the data from Figures 4 and 6 have been combined on Figure 7 to illustrate the relative degrees of movement measured at the crest of the quay wall over the worst affected section from 2000 to the present day. The figure clearly shows the rapid, and probably catastrophic, accelerating rates of movement in 2000, before the dewatering was switched on, followed by the relatively slow but continuing movements over the next 9-10 years, but increasing latterly.
