The Challenge of the Slope Failure Problem and Its Remedial Considerations at Mileage 39km, Mt. Ali Road, Taiwan

Chang M., Huang R.
National Yunlin University of Sci. & Tech., Taiwan

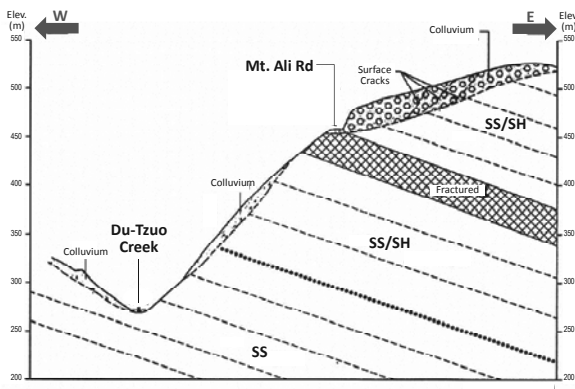
Figure 2. Geologic cross-section at the 39Km project site (CECI 2005).

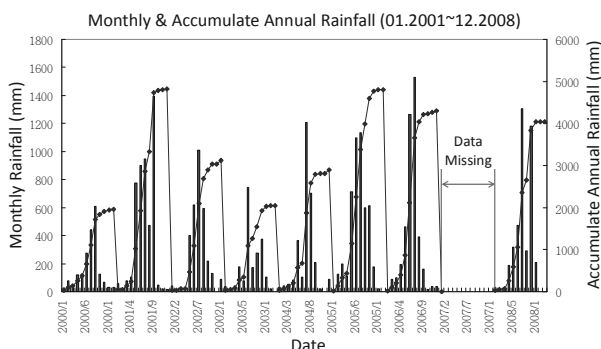
The monsoon season normally starts from early April to the end of September in the island. Annual precipitation is around 2150mm (Sinica 1999). Figure 4 shows accumulated rainfalls of the site in 2001 & 2005 were 4700mm & 4600mm, respectively. As will be discussed later, the abundance of rainfalls appeared to have contributed to the failures of slopes along the Mileage 39Km in 2001 & 2005.

Figure 4. Monthly and accumulated rainfalls at the site (Peng 2009).

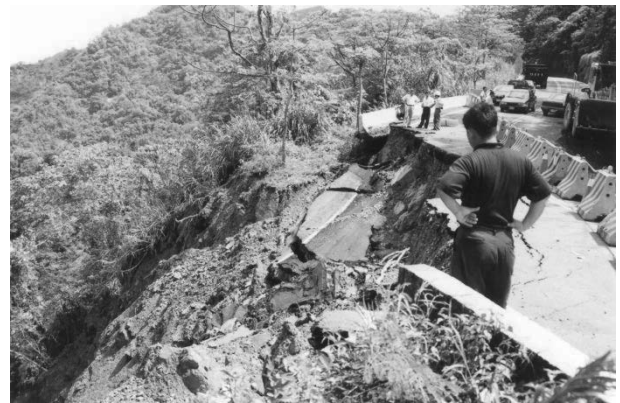
As the reconstruction work for the retaining structure was about to start in 8 months after Typhoon Nari, a failure in downslope of the road occurred (Figure 5). The failure was apparently due to the intense rainfall during the monsoon season. Recorded accumulated precipitation was greater than 1000mm within the two months prior to the failure.

Figure 5. Slope failure at Mileage 39Km due to 2002 monsoon rainfalls.

The original construction work had to be terminated and re-planned. In view of steep downslope and insufficient road width, DGH had once considered remedying the problem by cutting back and flattening the upslope. However, the plan was turned down due to unsuccessful negotiations with local ownerships of lands adjacent to the road.

The remedial plan was finally decided to limit within the extent of the road owned by DGH. Considerations of the road redesign had included a section of box-type concrete structure, as shown in Figure 6, which would provide a design with enough road width, structure rigidity, and relatively light-weight. The box structure was secured to the native ground by two rows of ground anchors, each of which with a total length of 35m, a horizontal spacing of 20m, and an anchor force of 45T. The

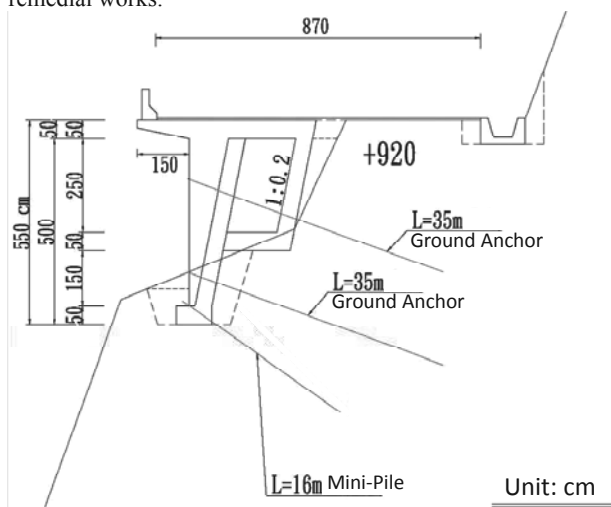
Figure 6. Box-type structure design for road section at Mileage 39Km.

base of the box structure was also fixed to the ground by a series of mini piles of 16m in length.

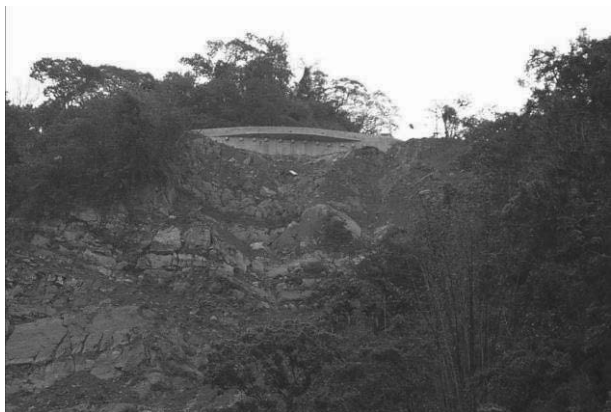
Figure 7 shows the rebuilt road section after completion of the remedial works.

Figure 7. Completion of box-type structure at Mileage 39Km.

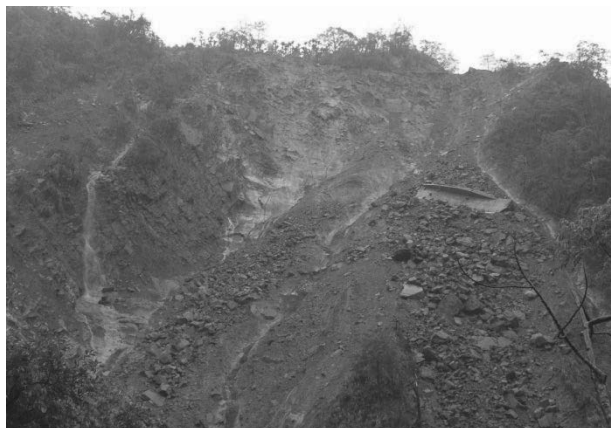
Figure 8. Failure of box-structure road section due to Typhoon Talim.

In late August of 2005, a severe Typhoon Talim slammed Taiwan. By considering a series of heavy rainfalls in the previous two months, the accumulated precipitation of the year at the site had exceeded 4000mm. As a result, the box-type structure finally gave up and the entire road section of about 100m in length fell into the valley (Figure 8).

Post-failure investigation had revealed that the loss of entire road section was due to the downslope movement of the uphill slope mass which pushed the box-type structure, tore down the ground anchor tendons, and sheared off the mini piles.

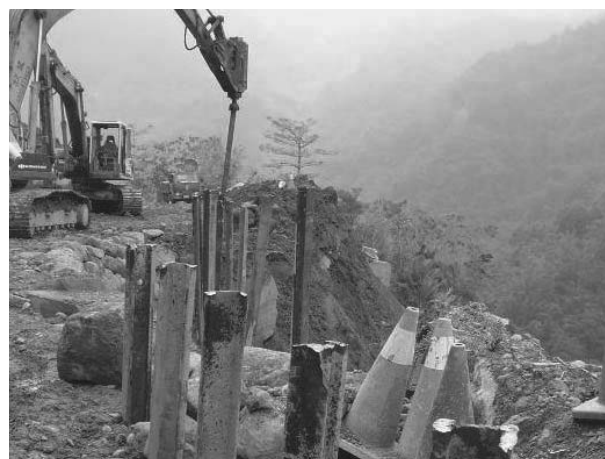
Emergency action was implemented right after the failure by constructing a temporary road to the uphill side and installing I-beams for the downhill support (Figure 9) in order to maintain the local traffic (DGH 2005).

Figure 9. Emergency repair of the road section due to Typhoon Talim.

In late September, 2005, the emergency measure failed again one month after the attack of Typhoon Longwang. The temporary road lost 5m of its road width. Site reconnaissance showed significant tension cracks at the crest of uphill slope.

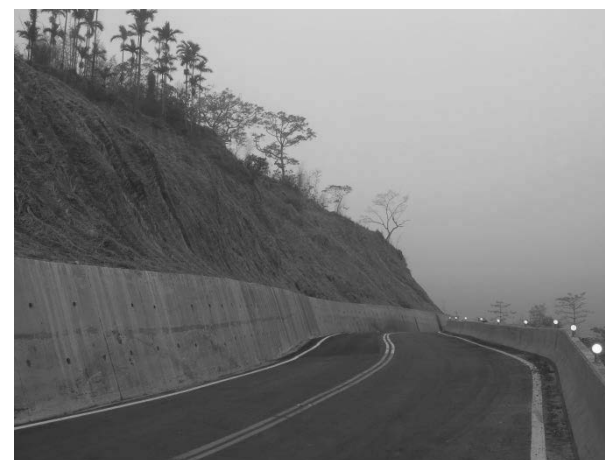
District V of DGH had to launch another remedial measure to mitigate potential impacts on the road section in the future. The plan had considered mostly the upslope protections that included filling of tension cracks, rechanneling surface drainage, installing subsurface horizontal drains, and surface vegetation, etc. Figure 10 shows the completion of upslope remedial works after Typhoon Longwang.

Figure 10. Completion of upslope remedial works at Mileage 39Km.

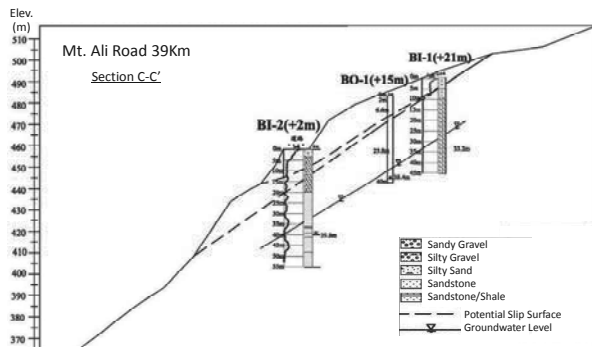
Figure 11. Material strata and potential slip surfaces at Mileage 39Km.

- The potential uphill sliding masses (Figure 11).
- The unprotected downhill slope surface that enhanced rainfall infiltration and surface runoff erosion.
- A long-term erosion of slope toe by Do-Tzuo Creek (Figure 12).
- The abundance of groundwater that was observed seeping out of the surface of downhill slope.
- The prolonged and intense rainfalls that infiltrated, saturated and softened the slope materials, increased the perched water level, and directly triggered the slips.

- Removal of potential sliding masses or reducing slope angle in the uphill.
 - Downhill slope protection including vegetation and drainage installations.
 - Road base and adjacent slopes strengthening by piling and anchoring.
 - Subsurface drainage installations in uphill & downhill slopes.
 - In-situ monitoring and warning system installation.
- The above measures appear to be sound from an engineering standpoint. However, the total cost and time for all of the above works would be extremely high, in view of difficulties in access for construction and generally incompetent subsurface materials at the site. Another option would appear more favorable as to reroute the Mt. Ali Road away from this difficult section.

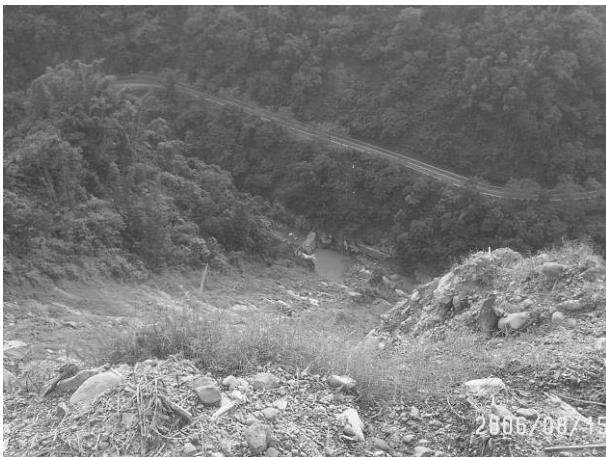
Figure 12. Downhill slope of Mt. Ali road section at Mileage 39Km.
