Geotechnical Characterization, Stability Analysis, and the Stabilization Process for a Landslide in a area of Barreiras Formation and Granite Residual Soils, Pernambuco

Coutinho R.Q.

Silva da M.M.

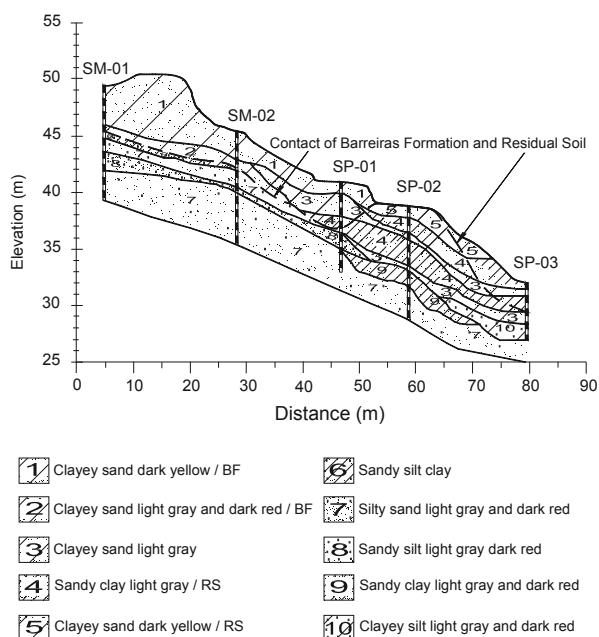
Soil profile cross-sections were detailed from the subsurface exploration, along with results from geological engineering mapping. Typical soil profile information is shown in Figure 1.

Figure 1. Typical Soil profile-cross section – post failure.

Results of the vertical readings from inclinometers confirmed the information obtained from the SPTs boreholes, showing that the failure surface seems to be very close to the contact between the Barreiras Formation, and the granite residual soils, measured to be located at a depth just over 7 m from the surface of the ground, the exception being the region around SP-02, where only residual soils are found.

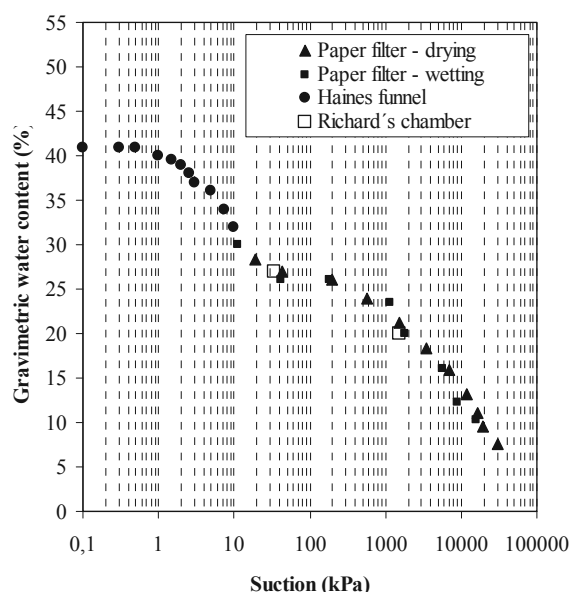
The soil-water characteristic curve obtained through the paper filter method, Haines funnel and Richard's chamber, is presented in Figure 2. The format of the curve displays a saddle aspect, allowing it to be divided into three distinct stretches. The curves indicate an initial air entry suction of 1 kPa, where desaturation begins. After that, a region approximating horizontal is observed, where suction varies from 20 to 200 kPa. In the last stretch, a second air entry value is depicted, where the water content starts to diminish with the increase in suction due to the removal of water from the soil micro pores (see more information in Silva and Coutinho, 2009).

Figure 2. Soil-water characteristic curve from mature residual soil from Camaragibe-PE - Silva and Coutinho (2009)

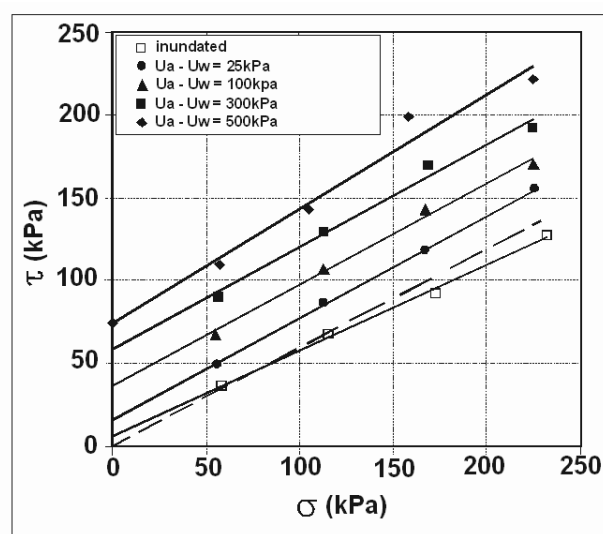
The shear strength envelopes in the plain (σ_v , τ) for the suction values of 25, 100, 300 and 500 kPa are represented in Figure 3. Envelopes considering suction of 0 kPa, obtained through conventional direct shear tests in the submerged condition, are also presented in this figure. It can be observed that the friction angle, in general, is close to 31°. The results indicate that the envelopes are near to linear in the stress range.

Figure 3. Shear strength envelopes for different values of suction - mature residual soil from Camaragibe.

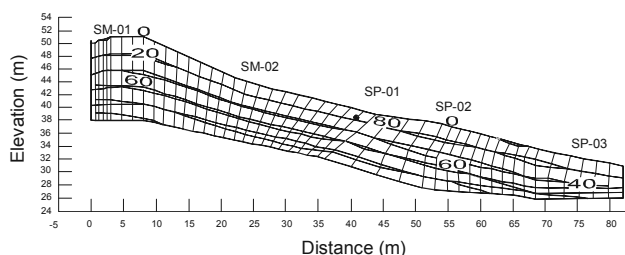
Flow analysis was performed for the failure condition, considering all the information from the studies, including the geotechnical profile, the geotechnical parameters of hydraulic conductivity for the materials composing the Barreiras Formation and residual soils, along with the rainfall and water level conditions. A summary of pore pressure distribution results is shown in Figure 4. Higher positive pore pressure values in the SP-01 and SP-02 regions were obtained showing ascends flow. These results are due to the variability of the soil profile and differences among the hydraulic conductivity values occurring for the materials. This condition is in conformity with water flow observed in this area during the period of intense rainfall.

With the flow analysis results that were provided, stability evaluation for global failure was initially performed (one-step failure) for the complete slope cross-section. The safety factor result was 1.278, showed not to be a condition for failure. Stability analysis was then performed considering the possibility of two-step failure, taking into account the concentrated high pore pressure values around the SP-01 region.

Figure 4. Flow Analysis – Pore Pressure Distribution.

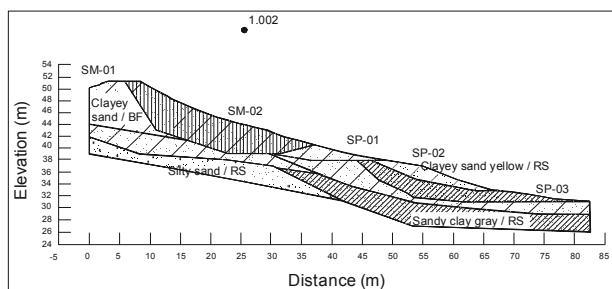
The first landslide occurred between the positions SM 02 and SP-01. For this case, the safety factor value was 1.002, for practical purposes, considered to be a condition of failure, and initiating the landslide mechanism in the area (Figure 5).

Figure 5. Back-analysis of the first slope failure – from SM-01 to SP01

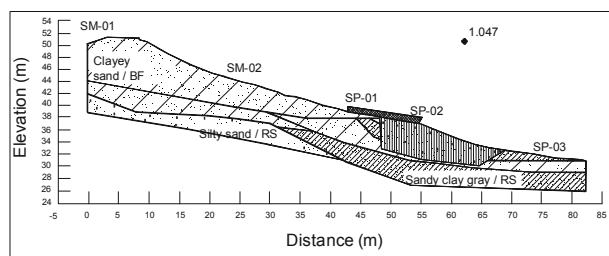
The mass that moved in this area (from the first failure) caused a surcharge estimated at 30KN/m between positions SP-01 and SP-02, which associated with pore pressure conditions, provoked the second step of the landslide. With this understanding, stability analysis was performed (back-analysis) using geotechnical information from the field and laboratory investigations. Figure 6 presents the minimum safety factor value obtained (1.047), confirming the displacements, and the failure mechanism considered to be the cause of the landslide that occurred in the area.

Figure 6. Back-analysis of the second slope failure – SP-01 to SP-03

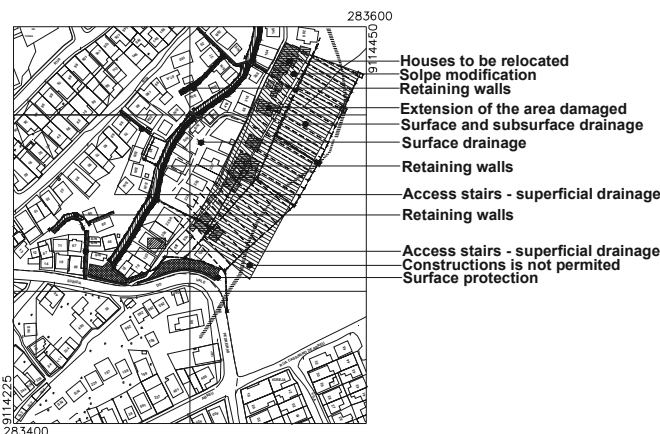
After three years, another intense rainfall period amplified the problem, with cracks forming in many other houses, and extending the area initially showing damage. See the right side of the two upper-center squares of Figure 7.

Figure 7. Measures Proposed for Mitigation and Control

The stabilization measures proposed for all damaged areas (initial and extended areas) included: surface and subsurface drainage (sub-horizontal drains), surface protection, placement of access stairs with surface drainage, modification of slope shape, installation of retaining walls, definition of areas where occupation was to be prohibited, definition of houses to be relocated, dissemination of information to the public, and raising overall awareness of the conditions, along with community consciousness. Figure 7 shows some of the mitigation and control measures proposed.
