Collapse behavior of slope due to change in pore water pressure

Nakata Y., Kajiwara T., Yoshimoto N.
Yamaguchi University, Ube, Japan

ABSTRACT: In 2010, a slope failure occurred due to heavy rain following an elevation in ground water level. Although a significant rainfall was experienced at the site in the previous year, there was no deformation with a similar elevation. In the past several collapses were recorded at the site due to heavy rain. Thus tests were performed using a plane strain compression apparatus to understand the deformation behavior of sand subjected to cyclic loadings in pore water pressure which were simulated the observed data on the collapsed slope. Rainfall records and data obtained from the observation well and extensometer were also shown. Finally lessons learned from the data were outlined.

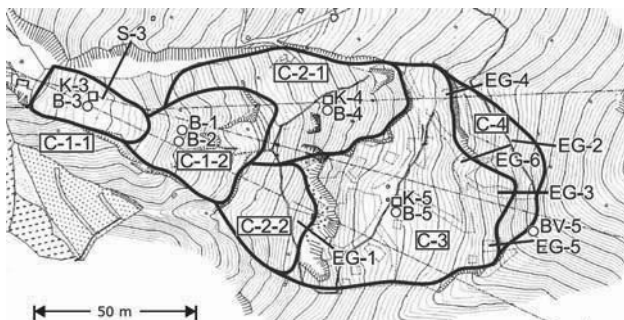
permeability. Previous failures have occurred at the site in 1973, 1981, 1991 and 1994. In 2000, a landslide occurred as far as the lower debris flow barrier. In 2002 ground surface movements were observed without any apparent flow of soil mass. In order to monitor the stability of the slope, a monitoring system was installed since 1988 as shown in Figures 5 and 6. The main parameters measured were rainfall, ground water level (GWL) and slope movements using extensometers. The data were recorded remotely at the National Highways Bureau in Hagi. The system was upgraded in 2004 by installing inclinometers in the slope and debris barrier. In addition, a strain-gauged tell-tale system was installed across a crack in the barrier. The data logging and communications system was updated with wireless technology. The data has been automatically updated on a website. Moreover a mailing notification system has been installed in case of unusual conditions developing at the site.

Figure 5 Plane view with failure blocks and measurement points (“C” represents failure block, “S” and “EG” are extensometers, “B” and “BV” are observation wells and “K” are for inclinometers)

Three types of countermeasures were implemented to mitigate slope failure. Firstly the top third of the slope was covered with rubber sheeting to prevent inflow of rainwater. Secondly, water head relief tubes were installed below the area covered by the rubber sheets. And thirdly, a debris flow protection gallery was built over the road in front of the collapsed slope. This gallery was designed to resist an overburden of 4m thick of debris.

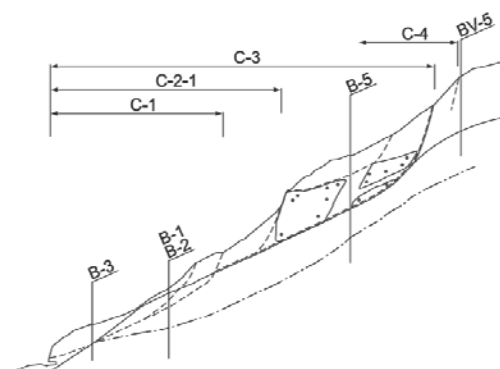
Figure 6 Cross section with failure block and measurement points

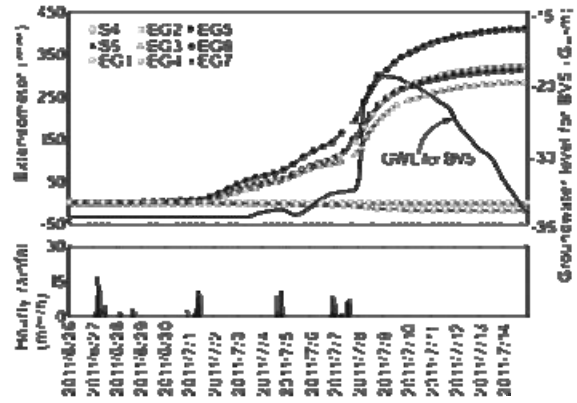
Deformation of the slope was observed in 2011 due to the smaller rainfall shown in Figure 10. The rainfall in 2011 started on 6/27 and continued intermittently to 7/17. For 21 days, 4 major daily rainfall events were recorded; 60mm on 6/27, 40mm on 7/1, 30mm on 7/4 and 50mm on 7/8. The extensometer began to act on 7/1 before the GWL for BV5 elevated on 7/3. From this date, the deformation increased gradually and accelerated on 7/7, rising with the rapid increase in the GWL. During the ground water level rise and descent, the displacement of the C-3 block was recorded. The maximum displacement rate appeared during the water level rise while in 2010 it was during water level descent. This implies that the

timing of the warning official announcement would be earlier more for the next heavy rainfall.

Figure 10 Data of extensometers observed at July in 2011
