Conservatoriumhotel Amsterdam, geotechnical design and monitoring

Stoel van der A.E.C.

CRUX Engineering BV Amsterdam & Universiteit Twente

ABSTRACT: This article deals with the geotechnical design of the building pit and the foundation restoration of the Conservatoriumhotel Amsterdam. It involves a selection of results of analytical and Plaxis calculations and damage predictions regarding vibrations and settlements. The second part of the paper deals with the execution of the works and the important role of a pro-active monitoring-system and careful communication with all stakeholders. It briefly outlines the monitoring plan, type and results of the monitoring and the risk management during implementation. Some measurement results are compared with predictions and two calamities that occurred during the construction will be specifically addressed. This will clearly show the added value of monitoring and active risk management, that eventually has led to the successful completion of this project in 2011.

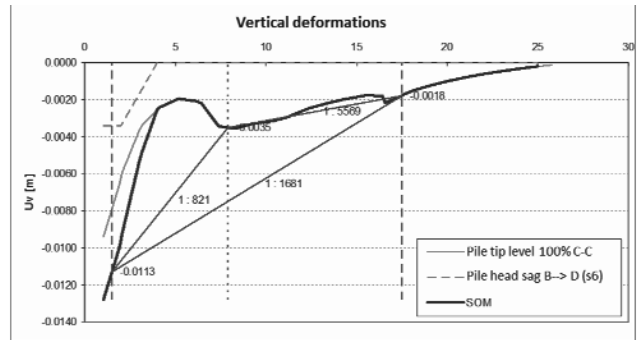
Because of the asymmetrical excavation and the need to assess soil and building deformations, 2D FEM Plaxis calculations were performed. In Figure 5 an example of the used model for section C-C is shown (see Figure 7). Based on the deformations and stresses resulting from this model, the vertical deformations and inclination of the existing building were determined, see Figure 6. The sheet piles and struts were designed in such an iterative way that the damage prediction resulted in an acceptable damage class (see Table 1).

Figure 6. Vertical deformations in building, section C-C.

u_v	L/H	β	E_h	Δ/L	ϵ_{tot}	Damage class
m	-	-	%	-	-	-
-0.0113	1:1605	0.066	0.0002	0.00088	-	Slight (minor aesthetic damage)

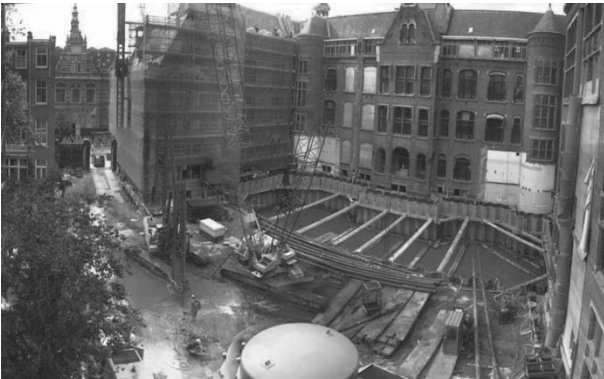
Incident 1 occurred during the excavation of building pit A. The situation at that time is illustrated by Figure 8 (by a recommendable, remotely operable, permanent webcam!) and Figure 9.

Figure 8 Overview building pit (at the time of incident)

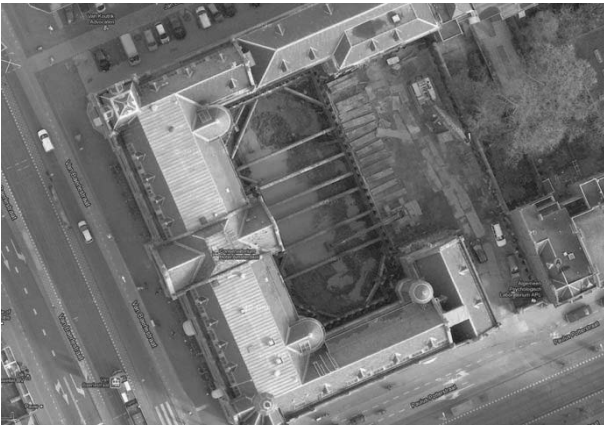
Figure 9. Top view building pit (at the time of incident; © Google)

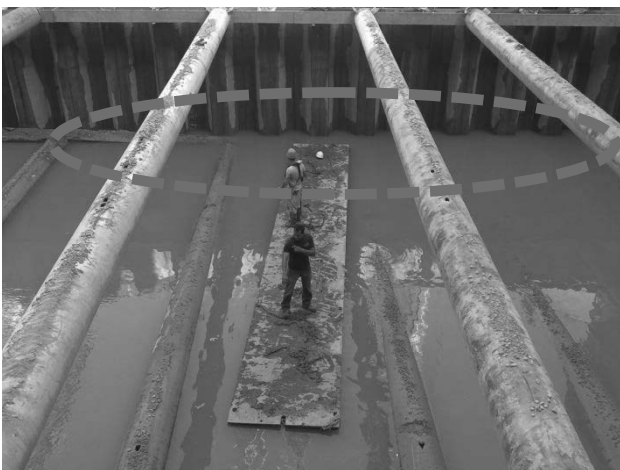
To limit the displacements the execution sequence has been that, after placement of the sheet piles and the excavation for the NAP -1,5m and -5,0m struts, the water table was first set up again before wet excavation to NAP -10,5m commenced. After hardening of the underwater concrete floor, the water table was lowered again. It was then timely discovered that the -5,0m struts and girder were not in position, see Figure 10. Pumping was stopped immediately to access the situation.

Figure 10. Situation at 2nd level girder (collapsed during excavation)

In order to be able to inspect the girder and struts, the water table had to be lowered further than calculated (-6,5m without strut). It was found that, probably because of excavating under the girder, it's consoles were removed, thus causing it to 'hang by a tread'. Because of the extensive monitoring and modelling, an alternative model could be made very quickly based on actual deformations, from which it could be concluded that the deformations resulting from the mitigating measures stayed within acceptable boundaries, see Figure 11. Thus, within three weeks and without significant delay in construction, the strut and girder could be repaired allowing for further excavation of the pit.

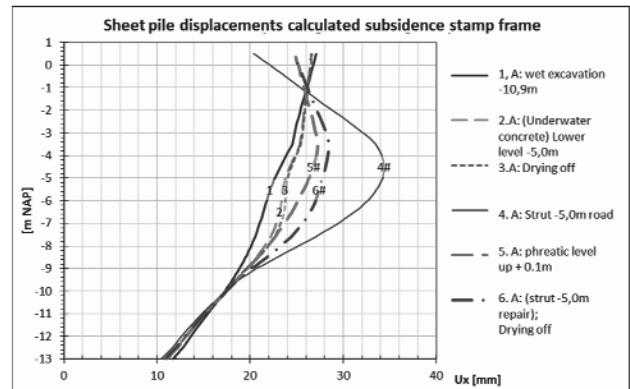
Figure 11. Inclinometer & predictions after incident at girder/strut -5.0m

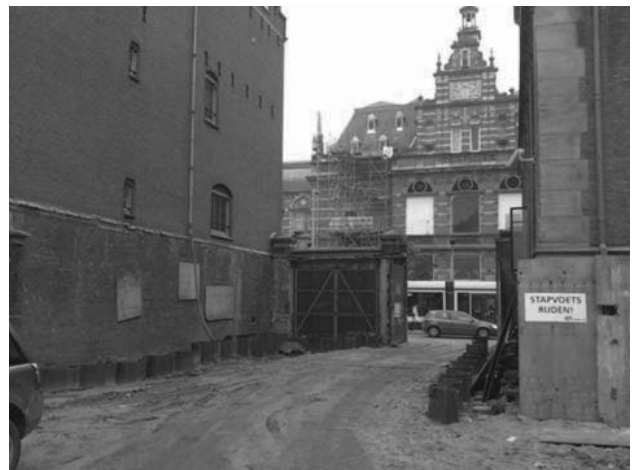
Incident 2 occurred during the excavation of the entrance at building pit B. The situation is illustrated by Figures 12 (before) and 13 (after excavation). At the left side of the pictures, a listed building at Paulus Potterstraat 44 (PP44) is located. During the excavation of building pit B, this building started to settle, as can be seen in Figure 15. The main concern however was that the side at the entrance settled significantly more than the opposite side, thus potentially causing damage.

Figure 12. Building pit at PP44 before incident

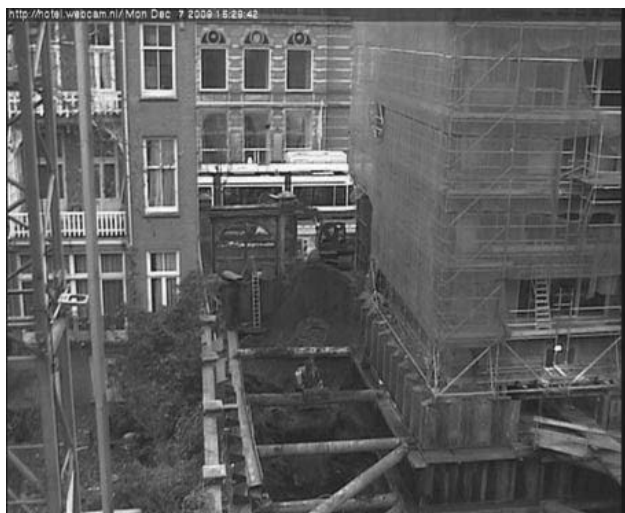
In November 2009 the monitoring showed that the settlement rate increased alarmingly. The frequency of monitoring was immediately increased and owner, contractor, consultants, insurer and the municipality intensively discussed a solution. This was found in a combination of allowing more deformation as long as no damage resulted from frequent building inspection and, more importantly, the remedial measure of pre-stressing the NAP -4,0m strut with 150 kN/m. The last measure resulted in a stabilisation of deformations that has held up to now. No damage to PP44 was detected.

Figure 13. Building pit at PP44 during incident

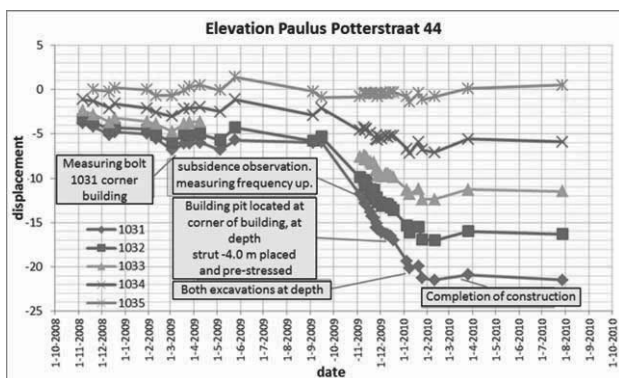
Figure 14. Displacement of building Paulus Potterstraat 44
