The December 29th 2010 Xerolakka Municipal Solid Waste landfill failure

Athanasopoulos G., Vlachakis V.
Dept. of Civil Engineering, University of Patras, Greece

ABSTRACT: On December 29th 2010, a 30 m high slope failed at the Xerolakka Municipal Solid Waste landfill in Greece. The failure resulted in temporary interruption of the landfill disposal activities and closure of the landfill access road; it also received significant media attention. A reconnaissance of the landfill slope instability was performed a few hours after the failure. Subsequent data collection, field investigations and numerical analyses were performed to better characterize the causes of the instability. Data collection included review of available data regarding the landfill design and the waste material at the Xerolakka landfill. Field investigations included Lidar surveying to closely map the post-failure geometry, as well as shear wave velocity measurements that were used as a basis for characterization of the MSW material and comparison with data available in the literature. Numerical analyses included limit equilibrium as well as finite element analyses. The results of the investigation indicate that t

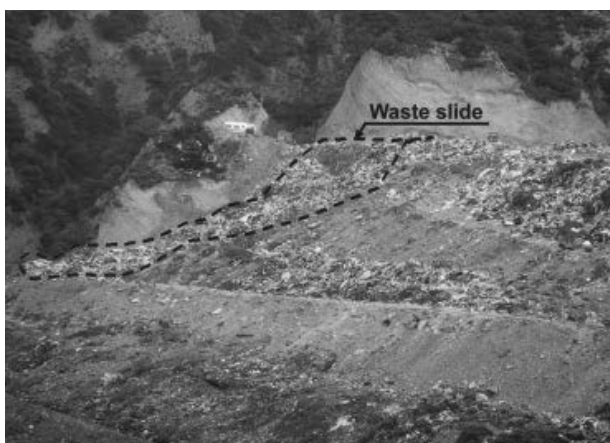
Figure 2. Waste slide view from the western side of the MSW landfill.

The uppermost layer of MSW in the active waste disposal area (i.e., the landfill crest) was not compacted and did not include any daily soil cover. The compaction of waste had reportedly ceased for at least a year prior to the failure and daily soil cover was not used for many months, possibly years. The absence of daily soil cover on the top waste layers can be seen at the right side of Fig. 2. In addition, the gas collection system was not operational.

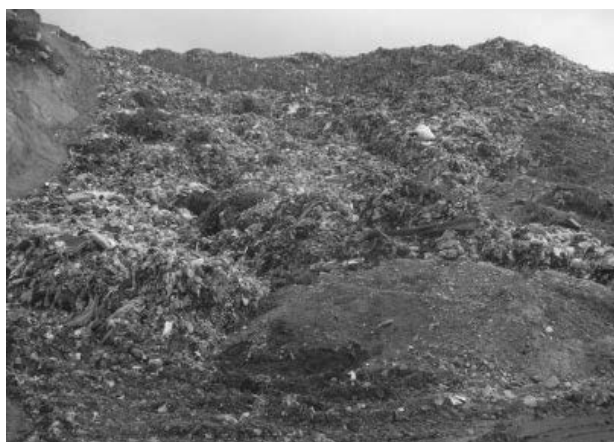
Figure 3. Waste slide view from the access bench located at the toe of the slide.

The waste slide is located adjacent to the graded canyon slopes with the Northeast portion of the slide exposing the native rock mass (also shown on the left side of Fig. 3). Precipitation on the steep canyon slopes in the vicinity of the

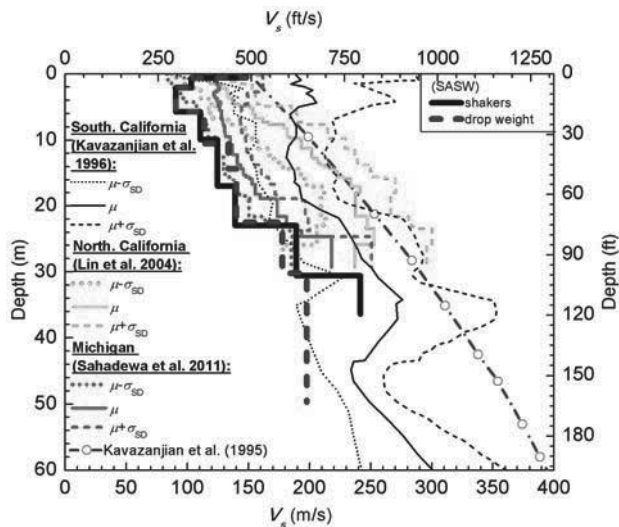
Fig. 4 compares the V_{S0} vs depth profiles measured at Xerolakka landfill with the data available in the literature. The mean and mean±sigma V_{S0} curves are shown for MSW in three geographic regions, specifically southern California (Kavazanjian et al. 1996), northern California (Lin et al. 2004) and Michigan (Sahadewa et al. 2011). It is observed that the in situ data from Xerolakka are in the lower range of the literature V_{S0} data. This difference may be attributed to a number of factors including waste composition, but more importantly the absence of waste compaction and daily soil cover. It should be mentioned that, following the waste slide, the placement of waste (from Dec. 2011 to May 2012) was carried out in a single thick lift (~8 m), overlain by a soil cover ranging from 1 to 3 m.

Figure 4. Comparison of V_{s0} vs depth profile at Xerolakka landfill with other published cases of landfills.

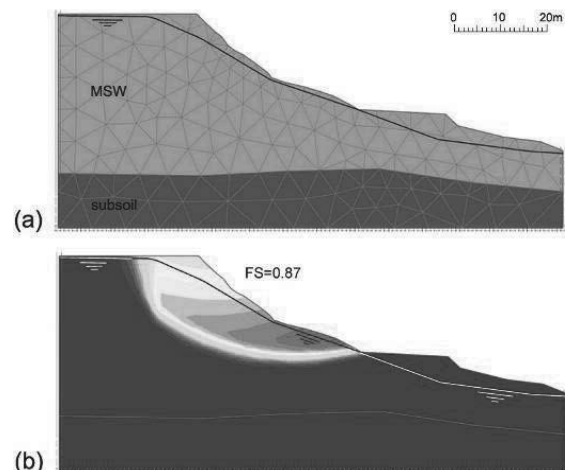
Figure 5. Finite element mesh (PLAXIS 8.6) of the critical failure surface with (a) soil stratigraphy and (b) critical failure surface for the estimated leachate table.

For these conditions, the factor of safety based on finite element analyses is calculated equal to 0.87, indicative of unstable conditions.

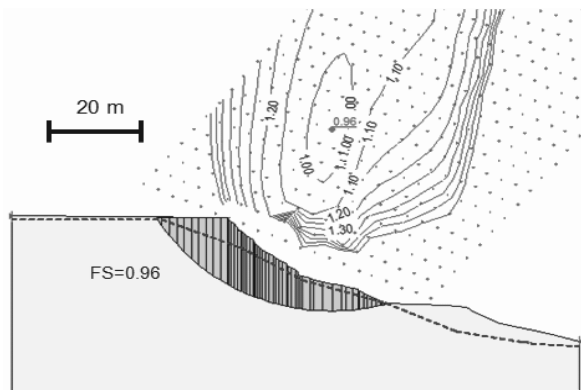
Figure 6. Limit equilibrium model (GeoStudio 2007 – SLOPE/W) with critical failure surface for the estimated leachate table.

Analyses using the limit equilibrium method (Geo-Slope 2007 – SLOPE/W) resulted in similar critical failure surfaces for dry conditions and for the assumed leachate table (shown in Fig. 6). The factor of safety is equal to 1.60 for dry conditions and 0.96 for the assumed water table.
