Reconstitution of foundation platform of Prasat Suor Prat by compaction of original soil with slaked lime, Angkor Ruins, Cambodia

Akazawa Y.

Japan Cultural Heritage Consultancy Co. Ltd.

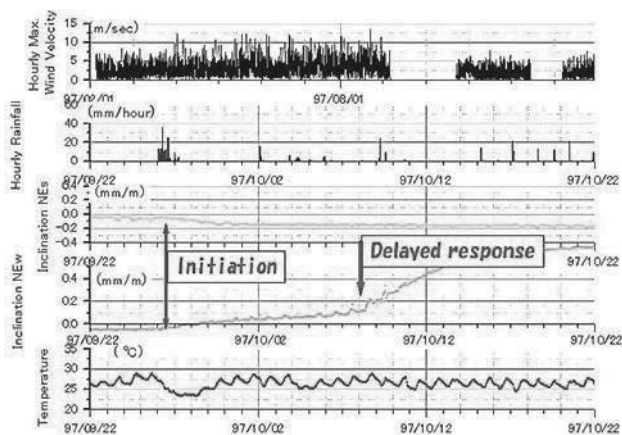
Figure 1. The measuring results of the amount of inclinations, the wind velocity, precipitation, and temperature of N1 tower.

The change in N1 tower's inclination with progressing time has been monitored by plumbing, however there was no significant change. During the rainy season in October in 1997, when there was wind velocity of over 10m/s blew for a few days, 0.5mm/m of the lateral displacement was measured. Figure 1 shows this monitoring data with inclinations, wind velocity, rainfall and temperature for N1 tower. This fact shows that the tower's displacement was increased by the external force acting against the tower (in this case, gust wind during rainy season), and this displacements will be accumulated.

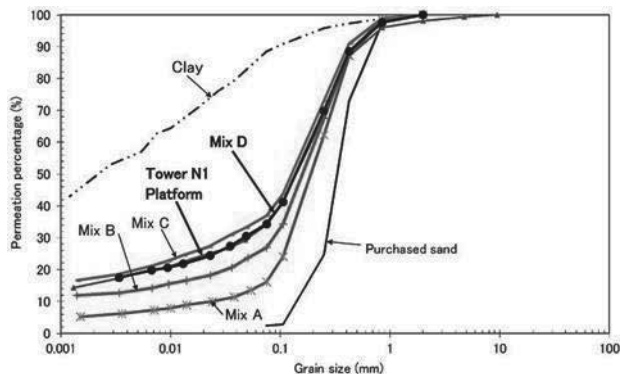
Figure 3. Grain size distribution curve of each soil

Photo. 2 and Figure 2 show soil strata under the platform of N1 tower. The compacted sandy formation was found from -1.5m from the original ground surface and to +3.5m above the ground, which the average thickness of one stratum was measured about 20cm. Figure 3 shows the grain size distribution curve of them. Figure 4 shows N-value distribution (by using standard penetration test) with depth. In figure white dots show the values in the dry season and the polygonal line shows them in the rainy season.

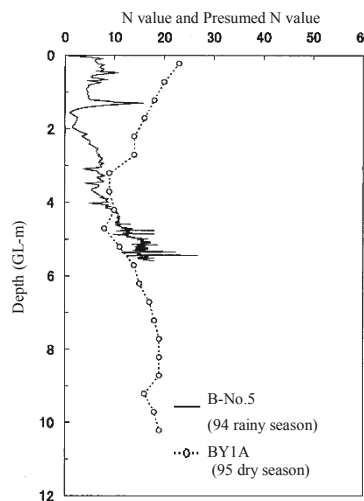
Figure 4. N-value distribution

Plate bearing in-situ test of plate loading on original compacted sandy ground showed the yield load of 290 - 340 kN/m² under wet condition. Since the contact pressure in the ground beneath the foundation of the tower was estimated at 270kN/m², the safety factor against the ground bearing capacity in rainy season was calculated at SF=1.1, which was considered as small and not safe. When the external force acts on the tower in the rainy season, the inclination, the subsidence and the differential settlement of them will increase.
