Some Technical Aspects of the Tailing Dam Failure at the Ajka Red Mud Reservoirs

Mecsi J.

University of Pécs, Engineering and Information Technology, Hungary

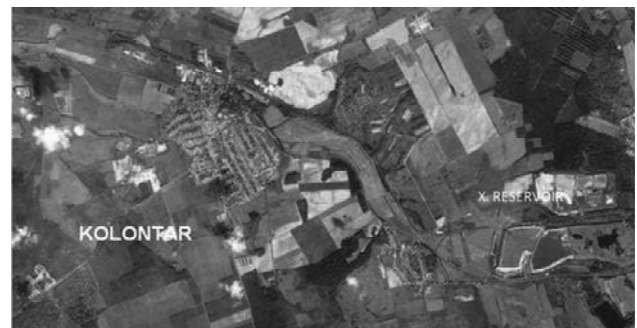
Fig.2. Natural-color satellite image of the area surrounding the spill

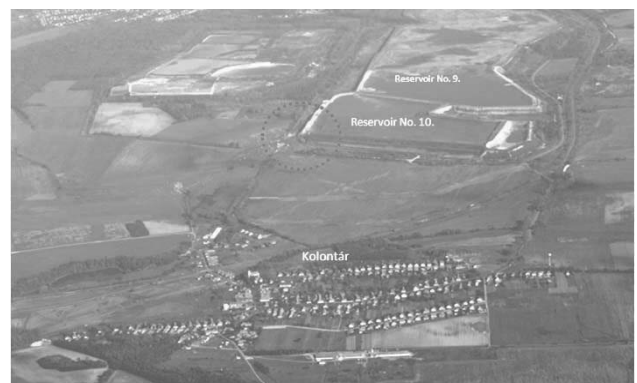
Fig.3. Natural-colour satellite image of the area surrounding the spill (<http://redsludge.bm.hu>)

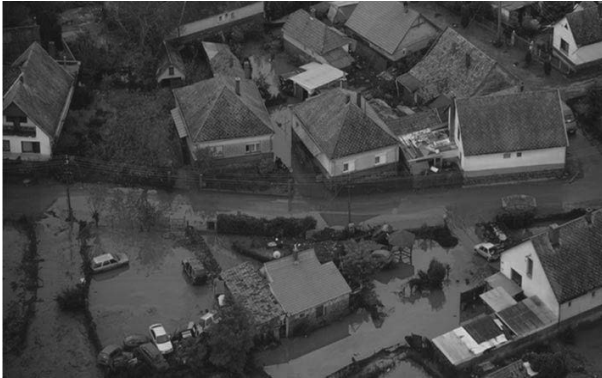
The red mud flooded the valley-side parts of the villages, then through the Marcal river it has reached the river Danube in very

short time. 10 people died, 123 injured, 260 houses became uninhabitable, and significant ecological damage occurred.

Fig.4. Aerial photo with the flooded territory of Kolontár (photo: MTI)

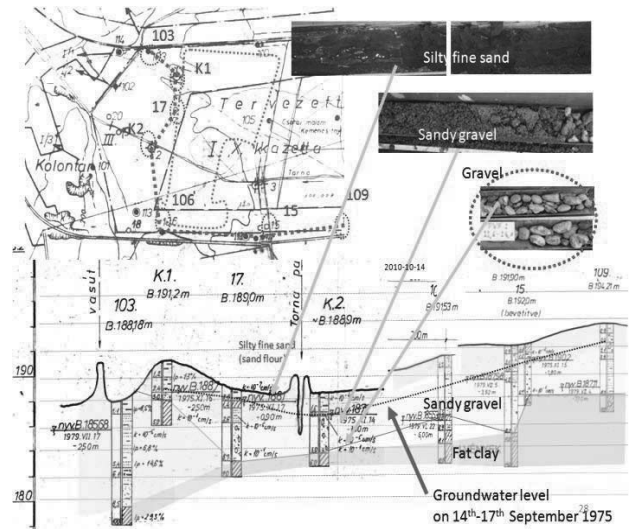
Fig.5. Illustration of the subsoil conditions of the reservoir system based on the original plans.

Figure 5 shows the subsoil conditions of the area based on detailed soil tests performed between 1975 and 1980. The territory had a basin-like character, fill with coarse gravel and sand and cover fine sand and silt, hence it had a swampy character, collected the water. The gravel terrace is gradually thinning towards the northern embankment. The „gravel basin” is bounded by a soft, easily liquefiable sludge layer of a plasticity index of $I_p=6.8-8.5\%$ and a water permeability of $k=10^{-5}$ cm/sec.

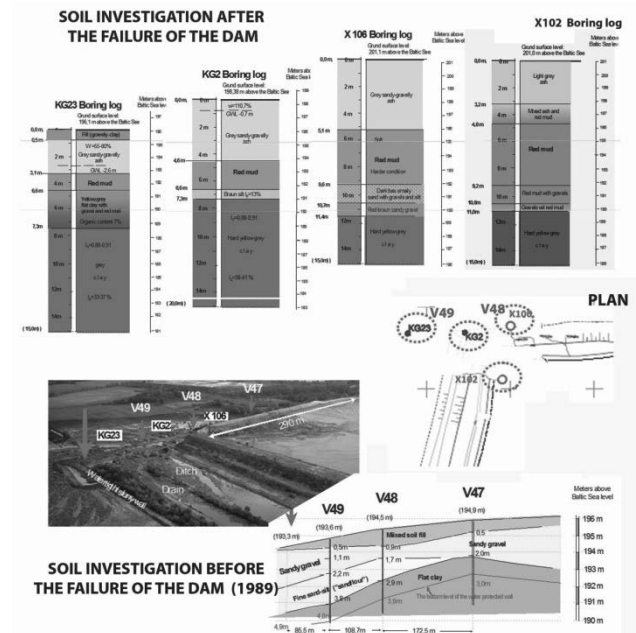
Fig.6. Soil profile near the West –North corner of the reservoir No. 10.

In the year 1989 soil excavations and geophysical measurements were conducted at the leg of reservoir No. 10's tailing dam, and the soil profiles were recorded. Figure 6 shows the soil profiles near the north-west corner. It is important to remark that near the north-west corner of reservoir No.10 sand-silt soils are to be found, and sandy-gravel layers above the fat clay. This soil layer unfavourable is that in fine sandy-silt fractions may move under higher water pressure conditions.

As a result, grain size becomes coarser on the inner side, while a „clay plug” may develop towards the edge of areas in motion. Such a clay plug is characterized by a sudden movement under a significant change in pressure and consequently a mudflow-like grain movement may evolve. Such a process may be extremely fast and unexpected.

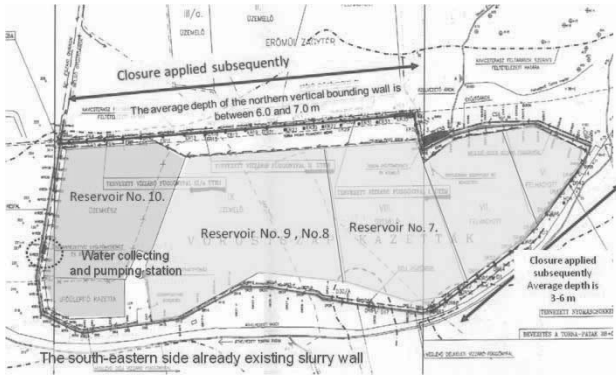
Fig. 7. Soil profile near the West-North corner of the reservoir No. 10.

Water pollution was detected in the groundwater monitoring wells near the reservoir system in the 1970s–1980s. In compliance with the regulatory requirements, a watertight slurry wall was constructed to close down the southern and the western sides of the reservoir. Figure 7.

Later, as the pollution spread over towards the north, the construction of a new type of grout curtain was started around the reservoir system in 1999. Depths of 6.0-9.0-12.0 m appear on the south-eastern side.

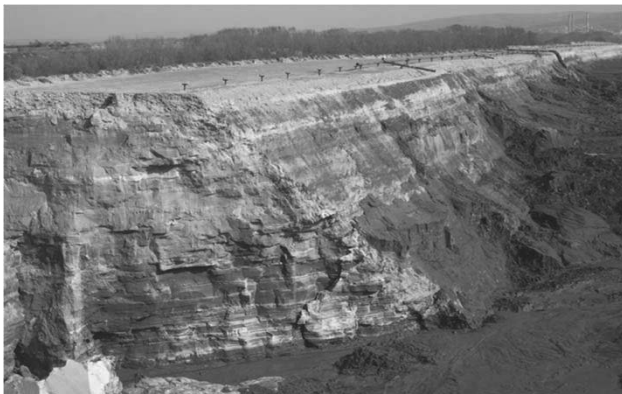
The boundary embankments show some special features. As they were made of slag and ash from the power plant, their weight is relatively low. Fig. 8.

Fig. 8. Material of the northern embankment of Reservoir No. 10 after the embankment failure.

Their average density is $\rho = 1.5-1.55 \text{ gr/cm}^3$, while their dry density is $\rho_s = 0,7-0,8 \text{ gr/cm}^3$, which is lower than that of water. The embankment is quasi-saturated with water. Due to the hydraulic chemical bond, the embankment is characterised by a relatively large strength. As a result of the construction technology applied, the embankment is layered and is of inhomogeneous structure, which manifests both in its strength and its water permeability characteristics.

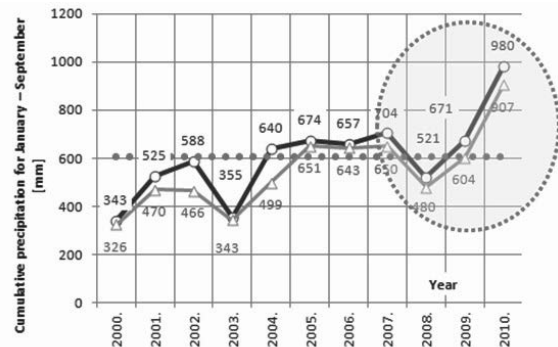
Fig. 9. Total precipitation data in the 1st-3rd quarter year between 2000 and 2010.

Comparing the total precipitation of the period between January and the end of September 2010 was 907÷980 mm, comparing the average of the 2000-2009 years data 513÷567 mm with 121÷131 mm standard deviation. (Fig 9.)

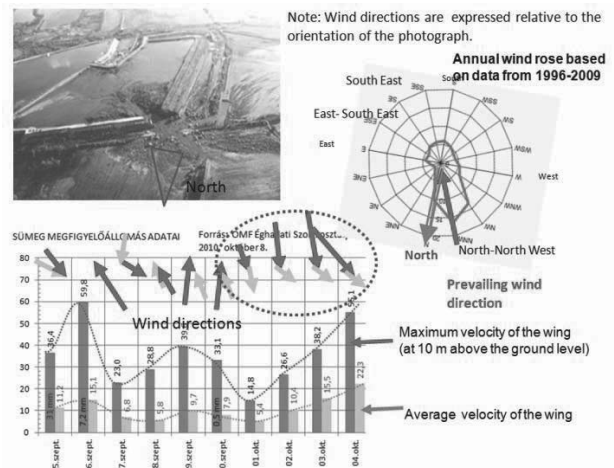
The prevailing wind direction in the vicinity of Reservoir No. 10 is northern-north-western as shown in the wind direction frequency chart. Wind parallel with the direction of the embankment failure is very rare (Figure 10).

Fig. 9. Vectors of prevailing wind directions and wind speeds between September 25.

Peculiar wind conditions were observed in the area between September 25 and October 4. Between October 1 and 4, a gradually strengthening, unfavourable wind speed toward the direction of the embankment failure was accompanied by casual wind gusts (Weather data services, National weather Services, October 8, 2010). The observations of the wind direction and speed were at 10 m over the ground surface, but the top surface the reservoir is 23-24m. It is mean that the wind speed in site should be significant more than the measured value. The highest wind speed values were measured on October 4, with an average of 22 km/h and occasion wind gusts of 60 km/h. There is reason to assume that these unusual wind direction and wind speed conditions contributed to the development of the embankment failure. The sucking effect of the wind on the northern side of the embankment must be taken into consideration.

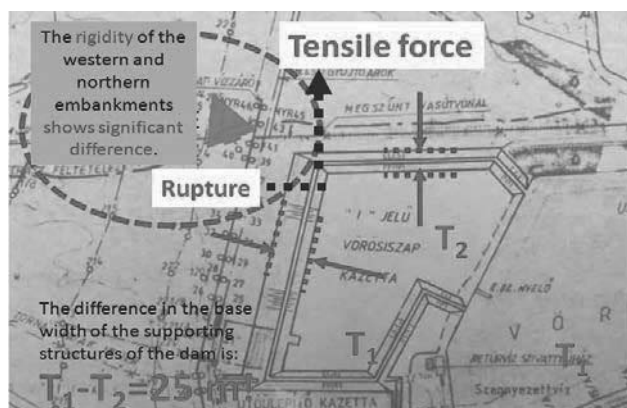
Fig.10. Dimensions of the western and southern dams.

The base width of the northern embankment is significantly different from the size of the other embankments, as it was considered a temporary structure, bearing in mind the possibility of a future extension. The slightly more than 20 m height of the solid part of the embankment is lower than the 26–27 m heights of the other embankments. Its effect manifested at the northern embankment – being by 25 m less in base width than the western embankment – as the resistance against displacement here was significantly lower, and also because the rigidity of the western and northern embankments showed significant difference at an unfavourable connection at the corner of the reservoir. (Figure 10.)

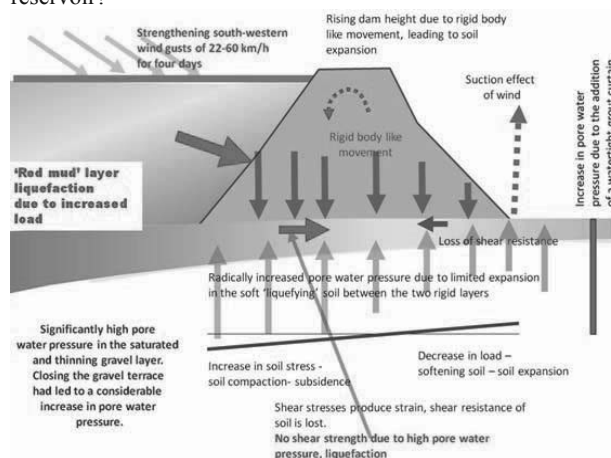
The geotechnical conditions were determined by the fact that at the northern boundary embankment of the reservoir there are beds of easily liquefiable muddy fine sand (or sand flour as described earlier) in a layer of 3-4 m located in the closest vicinity of the critical corner of the reservoir, adjacent to a sandy-gravelly layer.

Significant pore water pressure may have developed in the soil layer underlying the embankment as a result of the geological properties of the enclosed gravel terrace functioning as a drainage basin and due to extremely high precipitation levels causing high water pressure conditions.

The increase of load on the slope surface of the embankment might have contributed to the excess load – and the increase of soil stress – in the subsoil on the inner side and as a consequence, to excess subsidence, while it probably caused a slighter rate of expansion on the outer side due to the rigid body like movement of the embankment.

The extremely rigid but light embankment and the soft, liquefiable subsoil provided highly unfavourable static conditions.

The extremely unfavourable wind direction and wind speed conditions may have given a final push toward the very sudden embankment failure.

Fig.10. Summarizing some effects for the dam failure
