The use of hydro test results for design of steel tanks on stone column improved ground - a case history

Matešić L.

ABSTRACT: This paper describes hydro tests performed on five large storage tanks (80.000 m³ each) located at the Sisak Oil Terminal, Croatia. Because of its small stiffness and low water permeability, foundation soil for each tank was improved with 660 stone columns. In order to reduce the risk of accidents, such as fire, breach or leak, a crude oil storage tank requires stringent security measures. In the case of the Sisak tanks, the hydro tests were conducted as part of technical monitoring to determine a set of documented and interconnected activities which would provide proof of proper functioning of all elements of a tank structure. In case of critical deviations from the operation expected, such activities ensure that such deviations are removed or corrected on time by taking necessary measures approved by experts. Under a procedure for the hydro tests, the phases of tank and bund filling were defined and each phase was followed by visual inspection and measurements of settlements and deformations of the steel structure. Design directions for future foundation

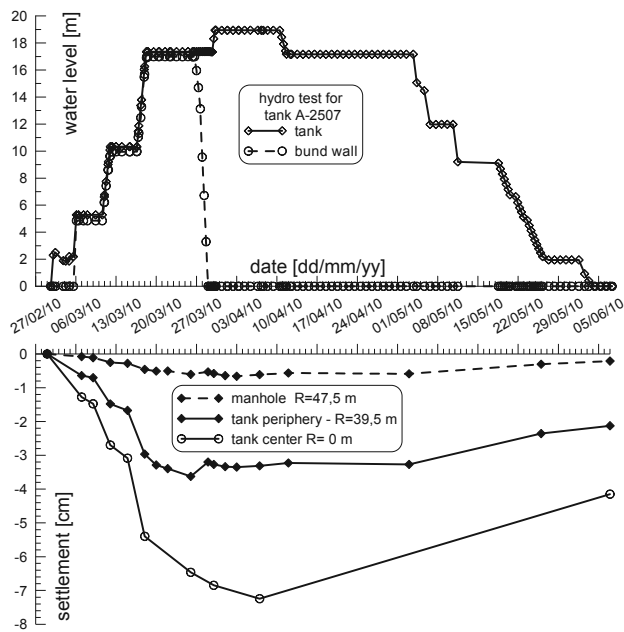
Figure 2 Time history of the hydro test performed on Tank A-2507

By way of illustration, the results of settlements obtained from the hydro test carried out on Tank A-2507 are given. Figure 2 shows time history of tank and bund filling and emptying together with the graphs showing averaged settlements of HI pipes at manholes HI, points on the foundation perimeter and centre.

According to settlement criteria (Marr et al 1982), the design defined allowable total and differential settlements for different settlement patterns. Thus, during the hydro test, the allowable total settlement of the tank perimeter and tank centre were 15 cm and 31 cm respectively. In a calculation, they were estimated to be 11 cm and 19,5 cm respectively. However, the results of measurement obtained for such settlements as shown on the graph were 3,6 cm and 7,2 cm respectively.

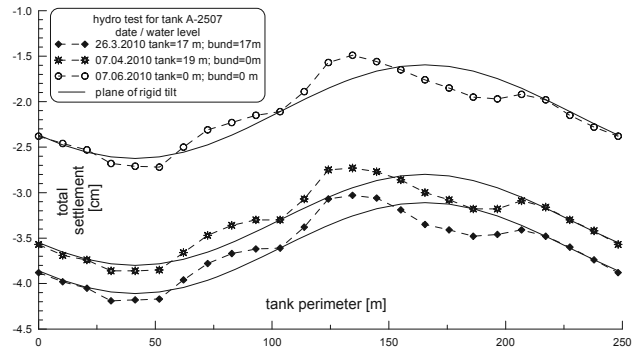
Figure 3 Total settlements of the tank perimeter occurred during the hydro test on Tank A-2507

Figure 3 shows total settlements of the tank perimeter for the two representative phases of the hydro tests in which the largest settlements occurred at the highest loads. In the third phase, i.e. when the tank was emptied, permanent (plastic) deformations occurred.

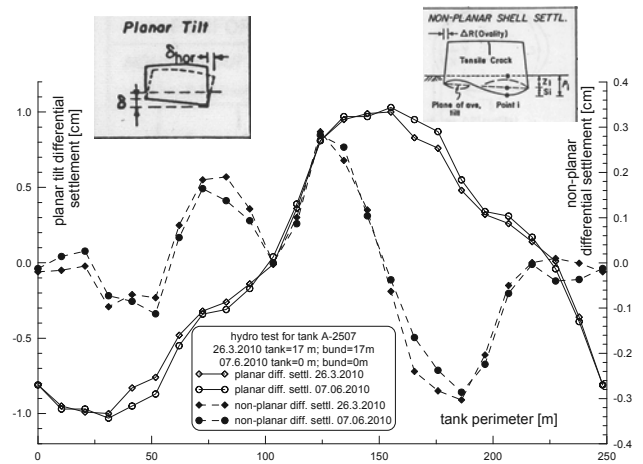
Figure 4 Differential settlements at the perimeter of Tank A-2507

Figure 4 illustrates the two phases in which the largest differential settlements of tank perimeter at the highest load occurred as well as the phase following tank emptying in which permanent (plastic) deformations occurred.

Design allowable differential settlements for the cases of planar tilt settlement and non-planar differential settlement was 44 cm and 0,8 cm respectively. The planar tilt settlement and non-planar differential settlement obtained by calculation were 1,3 cm and 0,34 cm respectively. The results of measurement obtained for such settlements were 1,0 cm and 0,32 cm respectively.

It was found that the settlements, after the tank had been emptied, were smaller although they had the same shape. This proves that the deformations after tank emptying are mostly elastic (Figure 4). As tank loads by crude oil are less than those by water, it is expected that subsequent displacements at operating load will be less than those recorded in hydro tests, and that no further non-planar differential settlement of the tank bedding will occur. The same goes for the other four tanks (Figure 7). The diagram of the settlements of all five tanks shows that such settlements are about the same when the tanks are subjected to the same load. As this is normally expected in the case of horizontally stratified soil, this is proof of proper and correct measurement of displacement.

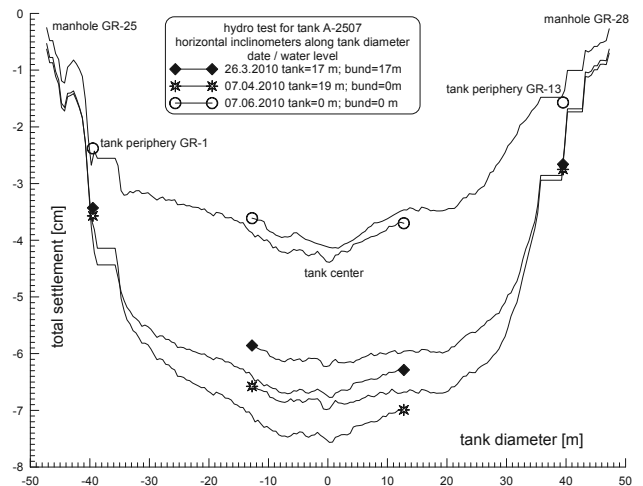
Figure 5 Total settlements of Tank A-2507 (cross-section)

Figure 5 shows total settlements for the three representative phases of the hydro test measured by horizontal inclinometer.

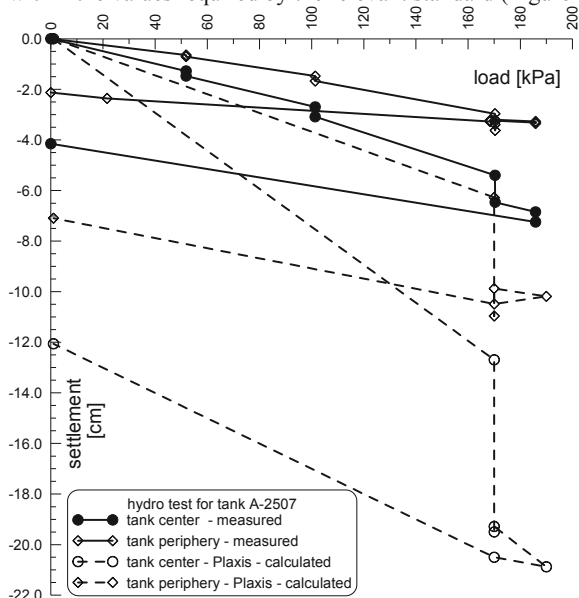
Figure 6. A comparison of measured and calculated results of settlements obtained from the hydro test on Tank A-2507.

The hydro test showed, as demonstrated in the case of Tank A-2507, that total settlements are relatively small, i.e. smaller than estimated by calculation (Figure 6).

As seen in Figure 6, the settlements obtained by calculation were significantly greater than those measured. An explanation for different values of settlements should be thoroughly investigated in further numerical analysis which will take into consideration the fact that columns and soil act together as recommended in Ambily and Gandhi (2004).
