The preservation of Agrigento Cathedral

Valore C., Zicarelli M.

DICAM - Dept. of Civil, Environmental, Aerospace and Materials Engineering – Università di Palermo – Italy

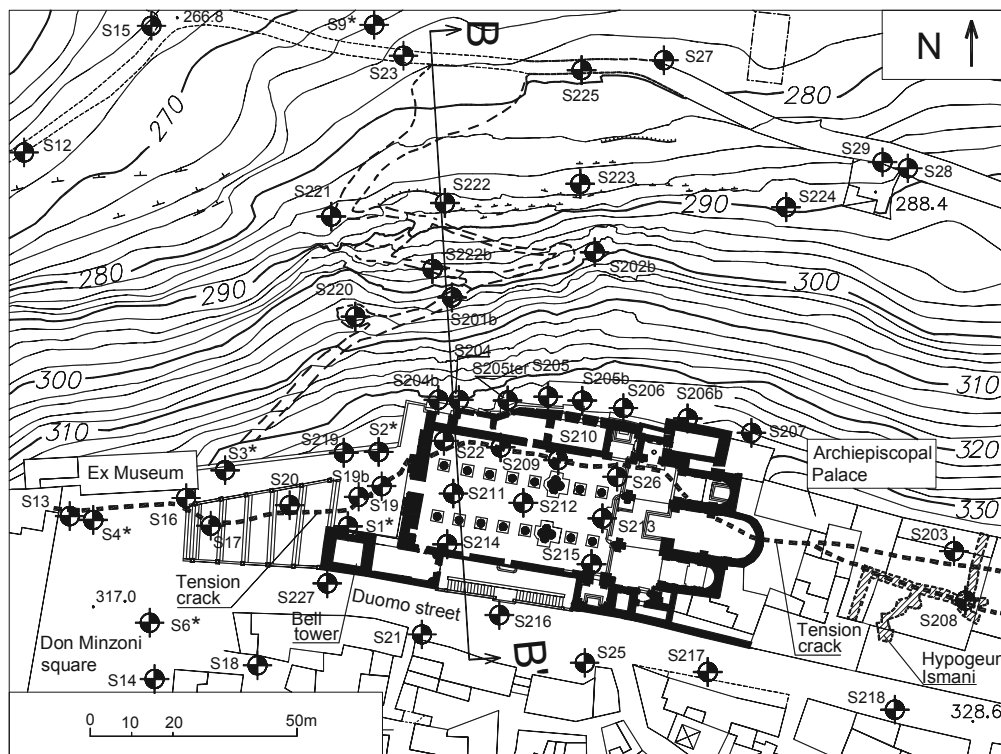
Fig. 1. Schematic plan of the Cathedral and of the adjacent slope, and location of the most relevant borings. It is also shown the longitudinal fracture or tension crack running through the northern aisle, the archiepiscopal palace and the Ismani hypogeous on the East side, and through the parvis and Don Minzoni square on the West side. Borings S201-S227 drilled in 2012; borings S12-S29 drilled in 2008; borings S1*-S9* drilled in 2005. Boreholes equipped with inclinometer tube: S1*, S2*, S3*, S4*; S13, S16, S20, S22, S26, S29; S203, S204, S207, S208, S209, S220, S221.

The most striking sign of ground movement is a longitudinal subvertical tension crack running in East-West direction through the floor of the northern aisle, and extending continuously to the parvis, the staircase and the Don Minzoni square, and in the opposite direction to the apse, the archiepiscopal palace and the Ismani Hypogeum as shown in Fig.1. This fracture has been firstly surveyed by Commissione del Ministero dei Lavori Pubblici for the investigation of the great “Addolorata landslide” (1968). The aperture of this fracture exceeds more than 20 centimeters in the Ismani hypogeum. After the restoration works completed in 2000, the fracture formed again in the Cathedral floor and in the parvis; its aperture slowly progresses and has now attained 4 cm. There is a step, from 2 to 3 cm high, between the northern and the southern walls of the fracture. The northern wall settled about 4 cm

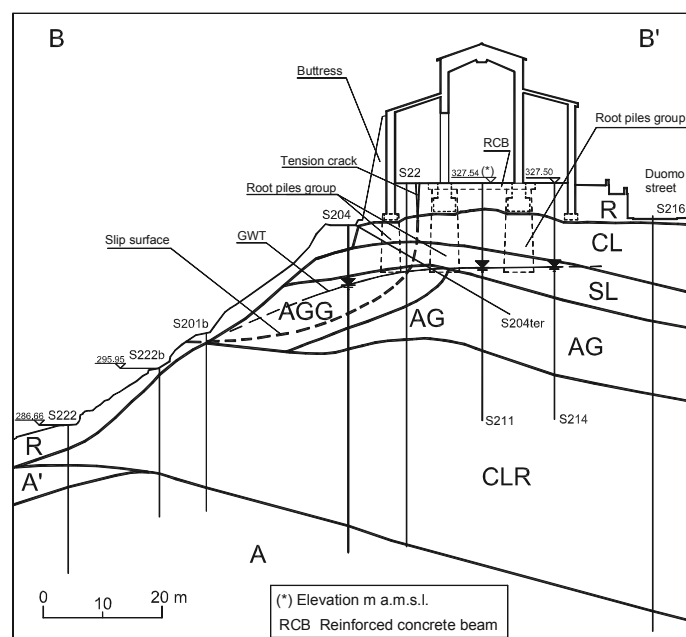
A schematic vertical profile of the ground is shown in Fig. 2. It may be noted that the various layers bend down when approaching the slope. Similar ground conditions have been ascertained within the zone relevant to the Cathedral.

CL, whilst the northern wall and a small stretch of western (facade) wall rest on intensely fractured calcarenites or on silty sands SL, see Fig. 2. The columns have been underpinned by groups of fourteen “root piles” about 15 m long, slightly inclined to the vertical so to describe a ruled surface flaring downwards (Lizzi, 1993). Each root pile was reinforced with a single, 24 mm diameter, steel bar. Shorter root piles were used to underpin the northern wall of the Cathedral. Root piles groups under the nave columns have been tied at the top by a grid of reinforced concrete beams. It is clear from Fig. 2 that the foundation ground of the Cathedral is far from uniform and that the thickness of the soft calcarenite layer CL diminishes or vanishes as the northern slope is approached. During the underpinning works in 1976-1980 it was ascertained that the CL calcarenite layer was dissected by a long and deep fracture (or tension crack) located inside the Cathedral near the northern wall, as shown in figures 1 and 2; it was “stitched” by cement pressure grouting.

Fig. 2. Vertical cross ground profile B-B'. R: made ground or topsoil; CL: upper soft yellowish or reddish biocalcarenes interbedded with sand lenses; SL: silty sands and sandy silts; AG: grey clays; AGG: grey-yellowish or light brown clay with veins of minute crystals of secondary gypsum; CLR: lower soft reddish biocalcarenes with sand lenses; A: heavily overconsolidated grey clays; A': grey-yellowish clays with gypsum veins.

Based on these data and observations it is possible to identify a slide mechanism shown in Fig. 2. Similar mechanisms apply for the whole length of the Cathedral and the parvis zone, the archiepiscopal palace and Ismani hypogeum.

The above mechanism appear to be the main reason for the anomalous behaviour of the ground-Cathedral system. It has not been identified nor postulated up to now, and consequently the attempts to stabilise the Cathedral were unfounded. The sliding mechanism passes along the subvertical fracture and through silty sands SL and altered clays AGG. A stability analysis of this sliding mechanism, which involves the North aisle of the Cathedral, points out that the use of peak or residual shear strength parameters of soils SL and AGG is not warranted. In fact, if peak parameters are considered values of the factor of safety FS within the range 1.4-1.6 will be calculated, whether if residual strength is considered a value of FS much smaller than 1 is obtained: these values are inconsistent with the observed behaviour of the ground-Cathedral system. It is likely that the shear strength is gradually approaching the fully softened value for which the value of FS is 1.05.

Recent geotechnical investigations permitted to identify a rather large sliding mechanism involving the North aisle of the Cathedral as well as long adjacent stretches of the edge of the slope. It is now evident that the preservation of the Cathedral requires prioritarily the stabilisation of the slope.

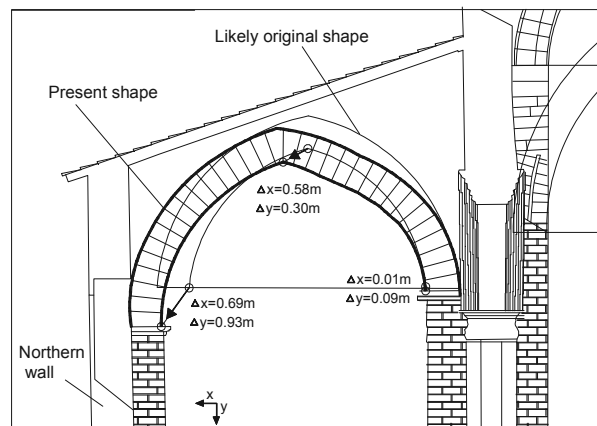
An idea of the cumulative differential settlements and horizontal displacements towards the slope of the northern wall can be drawn from the deformed shape of an arch transversal to the axis of the northern aisle and adjacent to the transept. According to a fairly credible reconstruction depicted in Fig. 3, the northern springline of the arch might have undergone an horizontal displacement so large as 69 cm and a settlement of 93 cm relative to the other springline.

Fig. 3. Distorted arch located at the eastern extremity of the North aisle showing large differential movements between the springlines cumulated probably during some centuries. (Reconstruction by Arch. G. Renda).
