The geotechnical analysis corresponding to the high road embankments close to a bridge

ABSTRACT: The paper presents a complex study case corresponding to a road embankment until 10m height placed at Iassy, Romania. It is about the access embankments at a bridge with total length of about 300m. After one year of service the studied embankments presented the following geotechnical problems: longitudinal cracks parallel and along with road axis, lateral knobs corresponding to each compacted layer, infiltrations through the backfill from the top (faulty pluvial system) and from the bottom (flooded foundation soil without drainage system). Foundation soil is metastable clay. Triaxial tests type CKoD on stress loading paths has shown that this soil is sensitive to moistening at shear stresses. The embankment is made also from a clay unusually used for such type of structures and several geosynthetic layers. At the top there is an elastic pavement. The footwalks over the embankment are from reinforced concrete and are bracket assembled. The finite element model has taken into account various hypothesis: 1. Model with the soils in natural state, 2. Model with foundation soil in flooded st

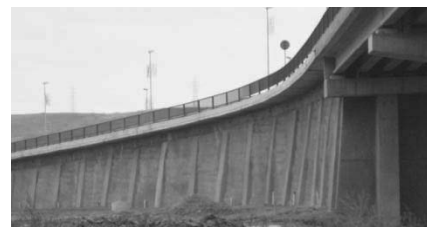
Figure 2 Lateral view of the embankment.

The object of this paper is to present the analysis of a road embankment with variable height (between 4-10m) placed at Iassy, Romania (Fig. 1, 2, 3, 4). This embankment presents from the first year of service longitudinal cracks parallel with road axle, lateral knobs corresponding to each compacted layer, infiltrations through the backfill from the top and from the bottom. The owner employed an investigation team to identify, analyse and propose consolidation work for this embankment.

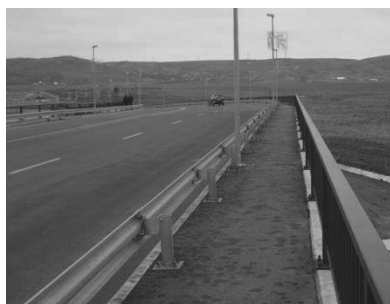
Figure 3 Longitudinal view of the embankment.

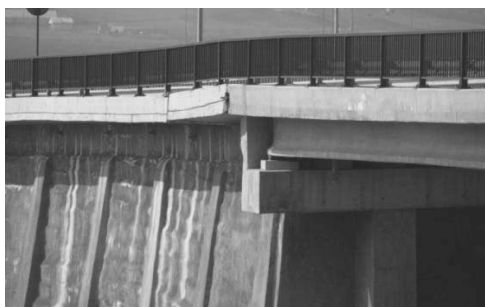
Figure 4 Zone between embankment - bridge.

- Foundation soil of embankment is almost every time of the year floded. Bahlui river is not flood controlled in that area.
- Backfill was loose on the edges of the embankment due to the lack of technology used in civil works (Fig. 4).
