# Refurbishment and Underground Space Development of Moscow P.I. Tchaikovsky Conservatory

Petrukhin V.P., Mozgacheva O.A., Skorikov A.V.  
*Gersevanov Research of Bases and Underground Structures, Moscow, Russia*

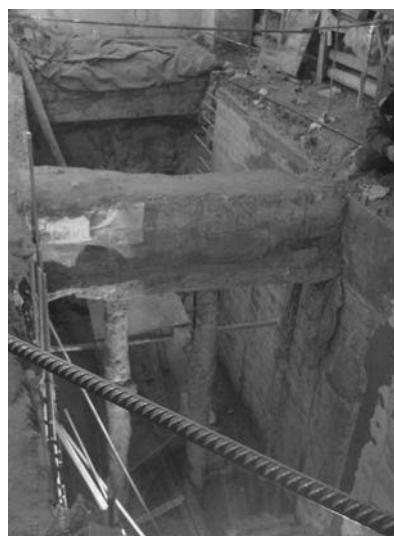
According to the above mentioned patent the hole drilling was accompanied by compaction and hole walls troweling to prevent water-saturated liquefied soil falling in the borehole. Figure 8 shows a photograph of a duct segment under the Big Hall, dug out manually to the design depth.

Figure 8. 4.5 m deep service duct

At the fore-front root piles, made in 2005, are visible, they are joined together by a concrete raft, they are a sort of struts. Soil excavation from ducts is a rather labor-intensive process, therefore, as dimensions of the premises were small, the soil was dug out manually.

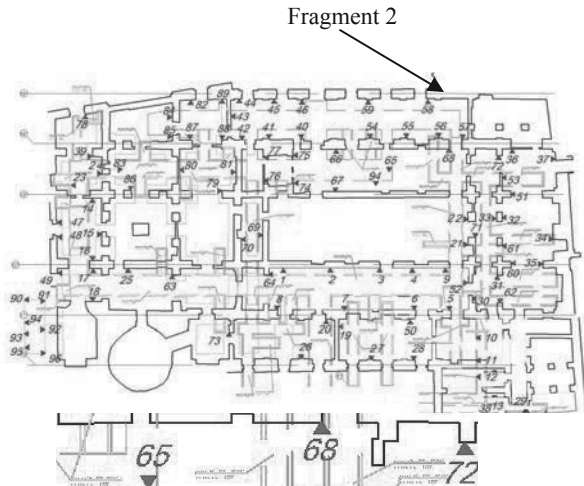
lements monitoring system. Nevertheless, geodetic monitoring of root piling operations, soil excavation and grouting operations was done daily, for 4,5 deep ducts it was done twice a day. Figure 9 shows geodetic markers layout, whose number exceeds 90 pieces to ensure registration of all relevant displacements of the structures.

Figure 9 Geodetic markers layout and check markers 56, 57, 58 layout fragment
