# Comparison of monitoring techniques for measuring deformations in an excavation

De Vos L., Van Alboom G., Haelterman K.  
*Geotechnics Division, Flemish Government, Ghent, Belgium*

Maekelberg W.  
*TUC RAIL, Brussels, Belgium*

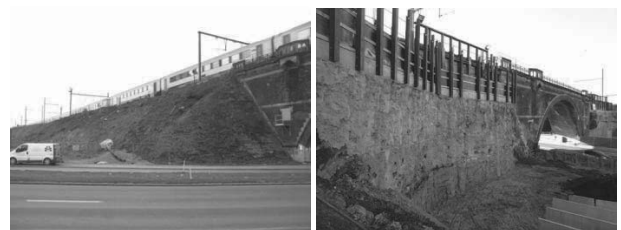
Figure 1. Picture of initial situation (left) and picture of the jet grout wall after excavation (right).

The monitoring site is located in Belgium, Anderlecht (Brussels), where an extra railway track will be constructed alongside the existing tracks. For the foundation of the new bridge, a nailed jet grout wall was installed next to the existing railway. By doing so, the soil could be excavated vertically and

the foundation could be realised in an open construction pit. The excavation depth is 12.5m starting from the railways. The jet grout wall starts 4m below the railway level and has a total length of 21m. HEB profiles with a length of 21m are inserted in the jet grout wall. Five rows of nails are installed over the excavated depth. Figure 1 shows pictures before excavation and after excavation. The excavation is executed in different phases. Each time 2m is excavated and consecutively, a row of nails is installed. After installation of the nails, the contractor waits at least 2 weeks before excavating the consecutive part. More information on the site can be found in Van Alboom et al. 2012 and Verstraelen et al. 2013.

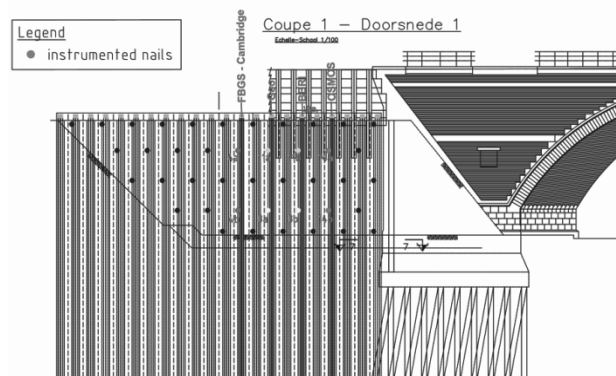
Figure 2. Front view of excavation with indication of instrumented HEB profiles.

The equipment for measuring the deformation of the wall or stresses in the wall, is placed on 4 HEB profiles which are lowered over their full length in the jet grout wall. Figure 2 shows a front view of the excavation site and the location of the instrumented profiles is indicated in red. Figure 3 shows a drawing and some pictures of the FBG and BOTDR fibers which are fixed to the HEB profile. The FBG fibers are fixed in small anchor blocks which are welded to the HEB profile (size of the anchor blocks is 18mm x 18mm). Those anchors are placed every 0.5m in the upper 8m of the profile and every 2m for the lower part. The BOTDR fibers measure the strain continuously, but are locally glued to the HEB-profile (every 0.5m and 2m) for better comparison with the FBG data. To measure deformations and moments perpendicular to the wall, fibers are placed on the top and bottom flange. To measure possible deformations parallel to the wall, two extra fibers are placed at the sides of the bottom flange. Extra L-profiles, placed above all fibers, are used as a protection during installation.

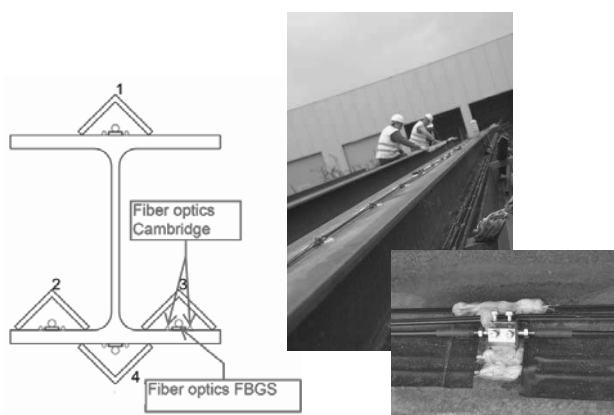
Figure 3. Sketch and pictures of a HEB profile which was instrumented with two optical fiber systems.

The other instrumentation was similarly fixed on the HEB profiles by welding or gluing.

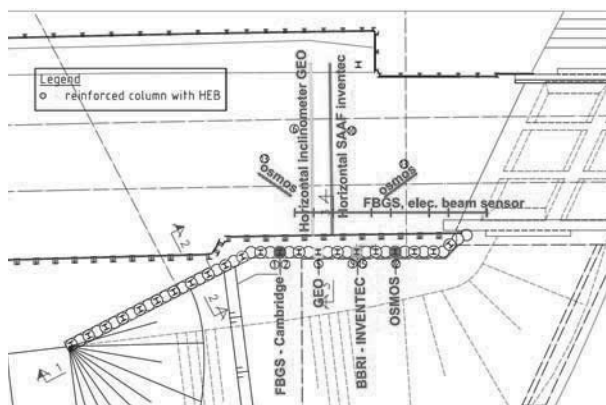
Figure 4. Top view of installed equipment.

- with two horizontal inclinometers (a traditional one and a continuous SAAF inclinometer) which are placed perpendicular to the wall in the ballast underneath the rails. The inclinometers are attached to a Berliner wall, which is located at one side of the rails. It is assumed that this creates a fixed point;

- topographically: the rails are marked with survey nails along a length of 100m and vertical deformations are measured by topographic levelling at different stages of the project;

- with electrical beam sensors placed on the railway sleepers; the beam sensor consists of an electrolytic tilt sensor attached to a rigid metal beam. The beam, one to two meters long, is mounted on anchor bolts that are set onto the sleepers. The sensors are linked end to end, as to allow displacement values to be accumulated from anchor to anchor to provide a profile of differential movements or settlement.

- with two optical strands, placed at a certain angle with the railway on the railroad tracks .

Figure 4 gives a top view of the instrumentation which is placed on or underneath the railway tracks. It also shows the different HEB profiles which were instrumented.

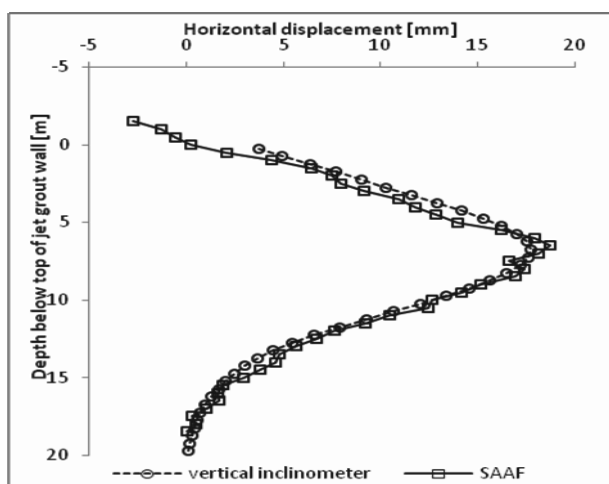
Figure 5. Horizontal deformation of the HEB profile on 07-03-2012.

Figure 5 shows the horizontal deformation of the HEB profiles, measured with the traditional inclinometer and the SAAF. These measurements are both made on the same date and are taken after the installation of the fourth row of nails. The excavation depth at that time is 7m. The data fit very well together. The data from the SAAF start above the reference zero level (which is the top of the grout wall), as the HEB profile did not reach full depth and protruded about 1.7m above the top of the grout wall.

The maximum horizontal displacement, measured after full excavation, amounts to 21 mm (26/04/2012) at a depth of 6.5m below the top of the grout wall for the inclinometer and 21.6mm for the SAAF. This lies very close to the calculated value of 22mm. It is found however that the direction at which the maximum deformation is found for the SAAF deviates slightly from the expected angle (perpendicular to the wall). This is probably due to a very small twist in between the different elements of the SAAF.

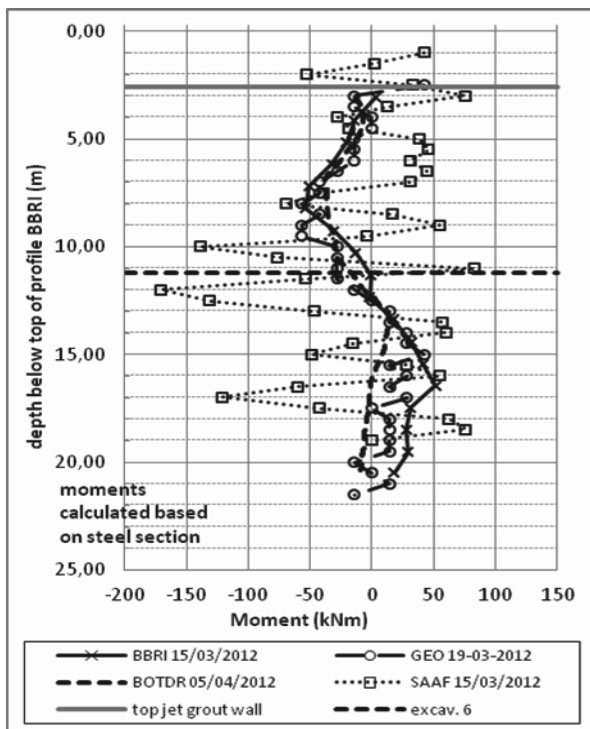
Figure 6. Bending moment HEB profile after the last excavation.

Figure 6 shows the bending moments derived according to Eq. 1 and Eq. 2 for the different measuring techniques (except for the optical strand, as this does not result in a bending moment as a function of depth). Unfortunately, a lot of the FBG sensors placed by FBGS failed during the first weeks after installation. For this reason, they are not included in the graph. For the stiffness of the wall, the stiffness of the HEB profiles was used, as the instrumentation is placed on these profiles.

Figure 6 shows that all derived bending moments give comparable values, except for the SAAF. This can be explained by the fact that the deformation measurements of the SAAF are less "smooth". As the bending moment is a result of the derivative of the measured inclination, this results in unexpected peak values.

A maximum bending moment of about 55 kNm is derived from the measurements. This is again in the same order of magnitude as the calculations (maximum calculated bending moment of 65 kNm). For the optical strand, the derived bending moment is about 35kNm, which is considerably lower than the other measurements. Due to the smoothing which is used for the BOTDR measurements, the peak bending moment is also reduced and has a value of 39kNm, which is also less than the value obtained by the inclinometer and the FBG technique from the BBRI. The shape of the bending moment curve however, is comparable to the other results.

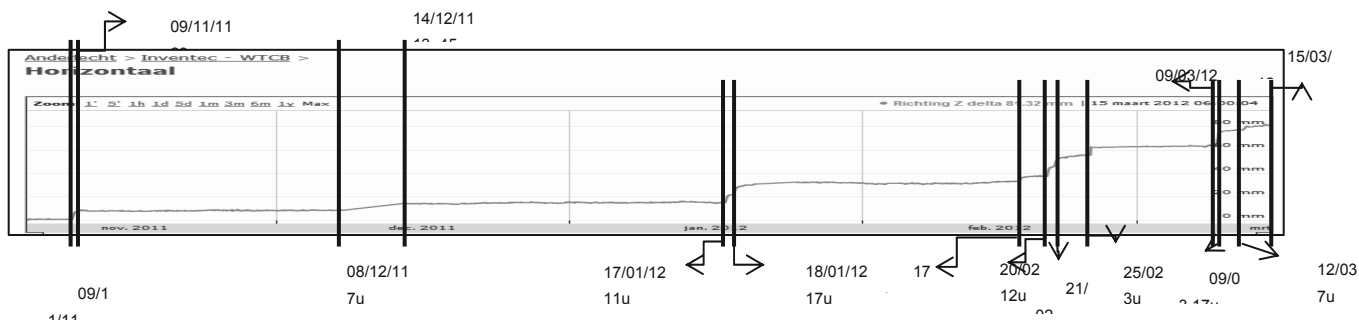
Figure 7. Maximum settlement as a function of time for the horizontal SAAF.

The calculated settlement prior to installation is 5mm. The measurements indicate a maximum settlement varying between 50 mm and 70mm for the different measuring techniques, which is much larger than the calculated value. Figure 7 shows the evolution in time of the maximum settlement value as measured by the SAAF. It demonstrates the great advantage of measuring continuously.

When comparing Table 1 with Figure 7, it can be seen that the discontinuities in the settlement curve correspond each time with the installation of the nails. In Verstraelen et al. 2013, it is explained that this is due to the execution of the jet grout nails. The settlement on 25/02/2012 is caused by lifting the tracks, due to which the inclinometer was locally displaced.

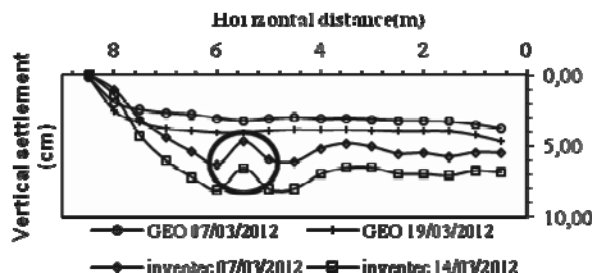
Figure 8. Settlements measured with hor. SAAF and hor. inclinometer.

Figure 8 shows the settlement measured by the horizontal inclinometer and the SAAF on two different dates. The zero settlement point corresponds with the fixed point on the Berliner wall. A significant difference between the settlements measured with the two techniques can be observed (approx. 30%). When comparing with the topographical levelling, it can be concluded that the measurements made with the horizontal SAAF are closest to the real settlements. This can be explained by the limited length of the inclinometer tubes (8m) and the fact that the stiffness of a traditional inclinometer tube is quite high for such a short distance (and large settlements).

The “bump” in the measurements of the SAAF (circled in Figure 8) is caused by the lifting of the tracks on 25/02/2012, as explained above. This “bump” has no influence on the settlement which is measured at the end of the railway tracks.
