# Inspection and Capacity Assessment of Anchored Slopes

Yeh H.n-S., Wang C.-S., Wei C.-Y.  
*Taiwan Area National Freeway Bureau, MOTC*

Lee S.-M., Ho T.-Y., Hsiao C.-A., Tsai L.-S.  
*CECI Engineering Consultants, Inc., Taiwan*

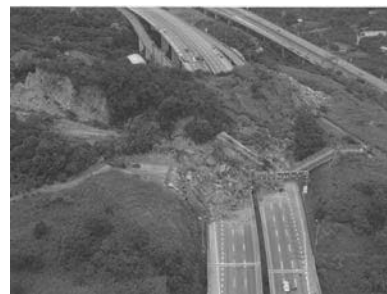
Figure 1. National Highway No. 3 at 3.1k accident

After the National Highway No. 3 incident involving ground anchoring failure, see Figure 1, a complete study had done on ground anchor inspection and assessment. Even so, the findings of the study were routine and not consistent among the investigators. This article will introduce and explain the currently most adopted ground anchoring inspection, procedure, and assessment. In addition, this article will propose a new way of ground anchoring assessment, in hoping to establish a standardized quantitative analysis procedure for professional reference.

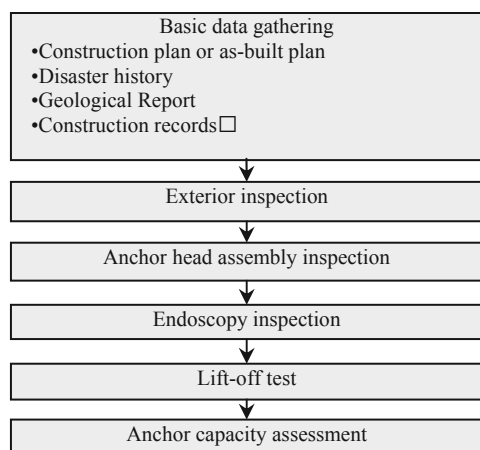
Figure 2. Ground anchor capacity assessment flowchart

Inspection procedure is as indicated in Figure 2. First gather basic data from all sloped terrains for ground anchor index, then remove all outgrowth on the slope, and check the entire ground anchors for outside appearance, pressure bearing integrity and water seepage status. According to the gathered data and inspection results, select the most typical anchor in characteristics of all anchors, remove the concrete casing to examine the anchor head and steel tendon closely, and record findings. After examining the anchor, use the findings to select partial ground anchors for endoscopy inspection to examine steel tendon corrosion and proceed with Lift-off Test, in order to understand the existing ground anchor Residual load ( $T_r$ ). Lastly, based on sloped terrain basic data and findings of various test results, evaluate in totality the ground anchors current capacity. If ground anchor capacities no longer meet the requirement of original specifications or there are other anomalies present which render the anchors inappropriate for continuing usage, then a proposal is required to improve or remediate the situation, including refurbishment, remedy, reinforcement or reconstruction as required.

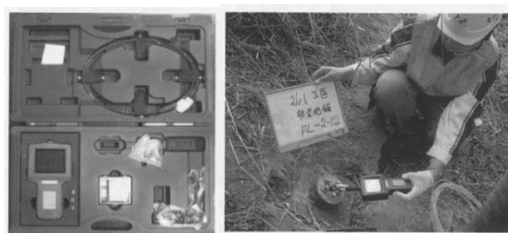
Figure 3. Equipment installation and operation

Endoscopy can be used to inspect the backside of anchor head and free section of steel tendon, to determine whether the steel tendon is corroded, broken or free section has water inside. Entire inspection process should be video recorded to allow further inspection and study back in the lab. The equipment used is as shown in Figure 3.

Besides inspecting steel tendon status, this stage should measure the steel tendon length of free section. The measuring technique is to use a stainless steel rod to insert into the anchor free section portion until the rod can not be inserted further, as Figure 4 indicated. Then record the length of the rod which was inserted, as such length can be taken as the exposed section length.
