Cavity remediation for pylon foundation of the Transrhmel Viaduct in Constantine

Steenfelt J.S., Schunk M.
COWI A/S, Denmark

ABSTRACT: The geology of Constantine, Algeria is highly influenced by previous seismic activities and the erosional feature by the river Rhumel. The Transrhmel Viaduct is a new river crossing featuring a 749 m long cable stayed bridge with a main span of 259 m and 80 m clearance. The soil/rock deposits are dominated by Marls of different strength underlain by Marlstone and very competent Limestone. However, exploratory boreholes for the foundation piles of Pylon P4 indicated the presence of possible cavities of up to 1 m high within the Limestone at the base of the upper weathered zone. To save 15 m of time consuming drilling of the 14 Ø2 m foundation piles into competent Limestone it was decided to end the foundation piles above the possible cavity feature in the Marlstone. The paper describes the innovative remedial measures carried out to safeguard the capacity of the individual foundation piles and ensure acceptable individual and overall displacements. The cavity feature was pressure grouted and transfer of axial load across the cavity into Limestone w

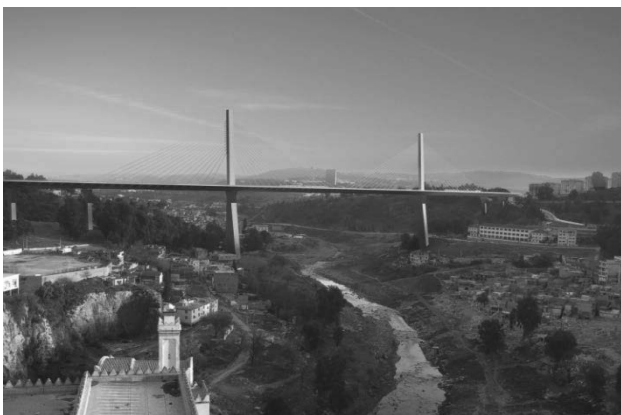
Figure 1. Artist's impression of completed cable stayed bridge (Pylon P4 to the left).

The Constantine Viaduct (Figure 1) is a new bridge, crossing the River Rhumel in Constantine, Algeria. Constantine is situated on a plateau at 640 metres above sea level. The city is framed by a deep ravine and has a dramatic appearance with a number of bridges and a viaduct crossing the ravine.

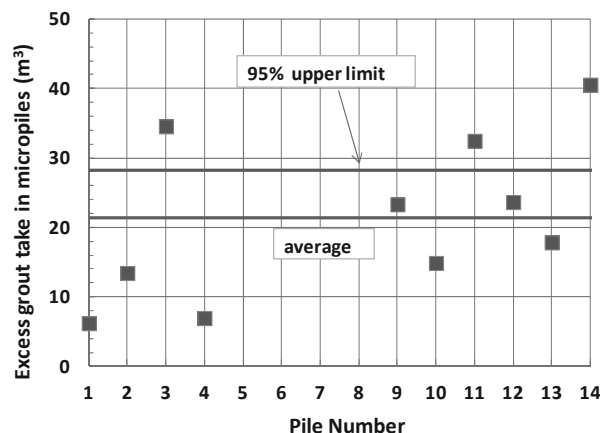
Figure 6. Excess grout take in "micropile" holes; (a) as function of sequence (2-6 weeks from grouting of fist to last pile); (b) accumulated values per pile location

As the Ø178 mm holes were re-drilled it seems likely that actual nominal consumption would be 115% of the theoretical consumption. Using this as baseline the excess grout take from the five reinforcement-holes below each of the ten Ø2000 mm piles are shown in Figure 6. In some cases re-grouting of the holes took place and hence a sequence number in excess of five occurs for some of the piles.

Although there is considerable scatter the excess grout take decreases by and large as a function of the sequence as would be expected as any cavity feature will be more readily filled during the initial grouting. Piles 3, 9, 11, 12 and 14 show grout take above average which is interpreted as a more persistent cavity feature at these locations.

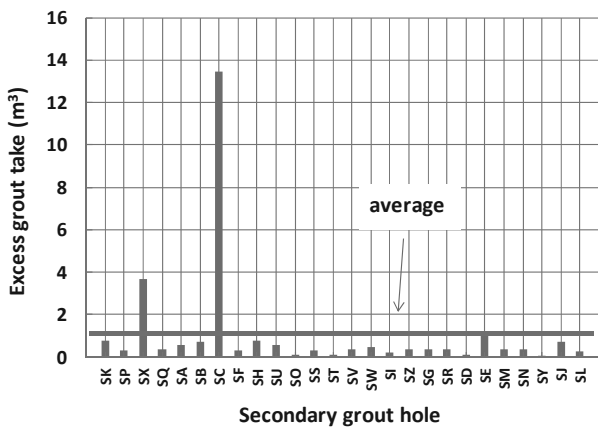
Figure 8. Excess grout take versus sequence for secondary grout holes

The actual sequence of the subsequent pressure grouting in primary (Figure 7) and secondary (Figure 8) deviated slightly from the sequence in Figure 5 but followed the principal intent. The theoretical grout take was based on the nominal drilling diameters but with reference to the considerations for the piles and pre-drilling holes this may entail some 15% underestimation of take.

As seen in Figure 7 and Figure 8 the excess grout take was very limited in the majority of holes.

The excessive grout takes over the average value are by and large concentrated in areas where a cavity feature had already been indicated by the "micropile" grouting. Furthermore, it is clear that the grout take during primary grouting ($1.9 \text{ m}^3 \pm 3.8 \text{ m}^3$) compared to the secondary grouting ($1.1 \text{ m}^3 \pm 2.6 \text{ m}^3$) is an indirect confirmation of the success of the grouting scheme.

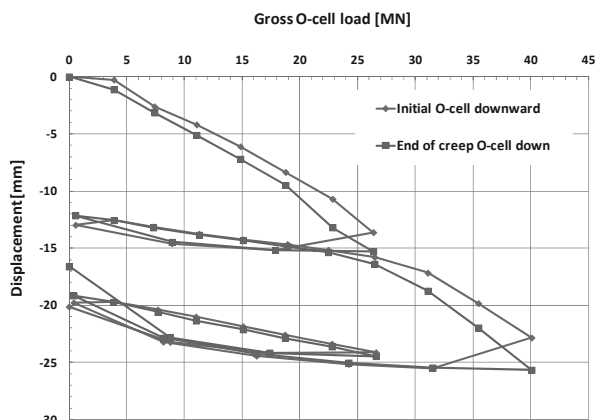
Figure 11. Displacement of lower O-cell plate versus applied downward gross O-cell load

The downward displacement of the bottom plate of the O-cells as a function of the gross downward O-cell load is shown in Figure 11.

A load of some 3 to 4 MN is required before displacements are initiated. This corresponds reasonably well to the tension capacity of the concrete section less the O-cell area (1.95 m^2) assuming $\sigma_t \sim 0.06 \sigma_c = 0.06 \times 35.5 = 2.1 \text{ MPa}$ and thus a breaking load of $1.95 \times 2.1 = 4.1 \text{ MN}$.

From Figure 11 it is apparent that the load-displacement curve is almost linear until the maximum load of 40.1 MN applied.

The maximum toe and shaft design loads for pile P4/3 are 4.5 to 4.9 MN and 21.0 to 26.5 MN, respectively. The range reflects upper and lower bound soil stratification and soil spring assumptions. As seen from Figure 11 and Figure 12 the load test indicates much higher values even within near elastic load-displacement behaviour.

- A maximum characteristic toe bearing stress of 11 MPa was conservatively assumed in the design. This stress was almost reached in the test but at a toe displacement of only some 25 mm, corresponding to a low degree of mobilisation (of the order 24%). Thus, the cavity remediation works, including the reinforcement of the weathered Limestone, has been successful and allows for a high toe bearing capacity in ULS (cf. Figure 11).

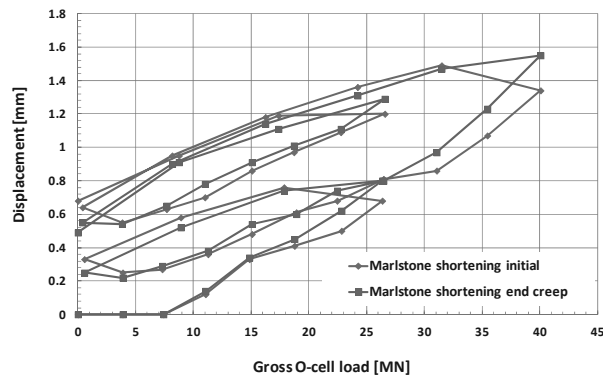
Figure 13. Shortening of the pile ("rock socket") in Marlstone between tell tales 1 and 2 versus applied O-cell gross load.

Tell tales 2 are at the transition from Marlstone to Marl 2 and hence the difference between tell tales 1 (top of O-cells) and 2 indicate the "rock socket" shortening in the Marlstone as shown in Figure 13.

This deformation corresponds to the accumulated displacement between pile and rock for developing the shaft resistance. As seen from the Figure the displacement is very small and almost mirrors the upward displacement of the O-cell upper plate (Figure 11). It means that the displacement between pile and rock at the top of the Marlstone is only 0.6 mm and thus the pile capacity is very significantly higher.

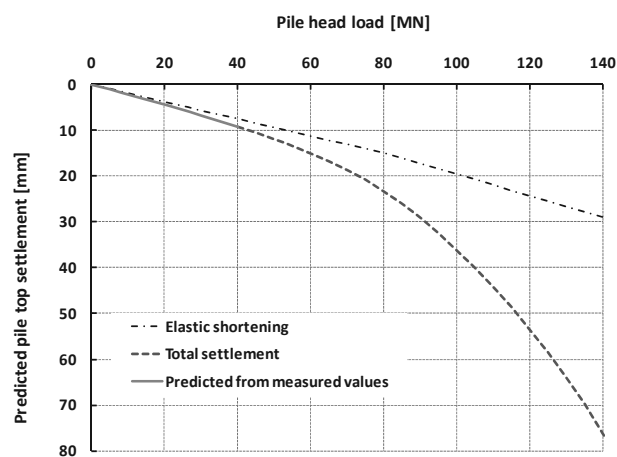
Figure 14. Predicted top load settlement curve for Pile P4/3

The methodology by Fleming (1992) was used to produce the predicted top load settlement curve shown in Figure 14.

It is apparent from Figure 14 that a top loading of 26.5 MN (corresponding to the maximum SLS load in the P4 Pylon pile group) will cause a pile head settlement in the order of 6 mm. Twice the load, 53 MN (twice the SLS load and larger than the maximum ULS load of 45.5 MN in the pile group) will result in only 13 mm settlement.
