# General Report du TC 301 Monuments, historic sites and case histories

Flora A.  
DICEA, University of Napoli Federico II, Italy

**ABSTRACT :** This general report presents and discusses papers dealing with the preservation of monuments and historic sites, as well as with some case studies related to problematic soils and to the design challenges they pose. The papers deal with a variety of issues and sometimes report different design approaches. They show that the themes discussed in this session are among the most challenging the geotechnical engineers and researchers have to face. In some cases, solutions have to be found taking into account the essential contributions of experts from different cultural fields.

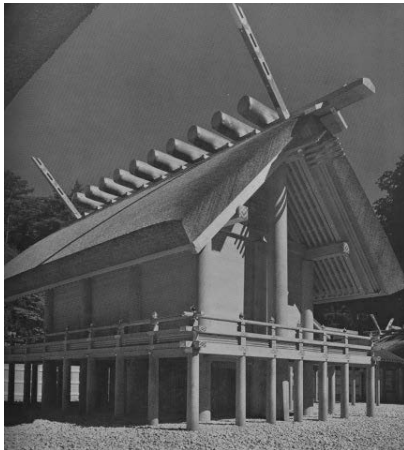
Figure 1. Ise shrine, which undergoes ritual reconstruction every 20 years ever since the 7<sup>th</sup> century.

substituting spoiled or damaged parts. Later on, all the Shinto shrines but one (Ise shrine, Figure 1) stopped the periodic reconstruction because of political and economic changes.

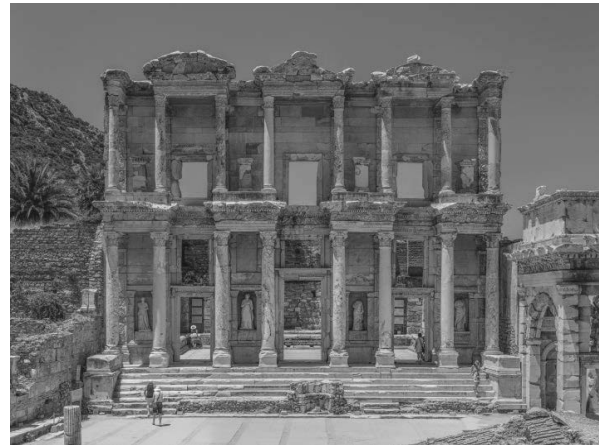
Figure 2. The façade of the library of Celsus in Ephesus (Turkey), a magnificent example of *anastylosis*.

explicitly stated by the Venice Charter “should be ruled out a priori”. Only *anastylosis* (meaning in Ancient Greek “to erect a structure again”), that is to say, the reassembling of existing but dismembered parts can be permitted (Venice Charter, article 15). However, it can be done only when possible without misinterpreting the original structural scheme (Figure 2).

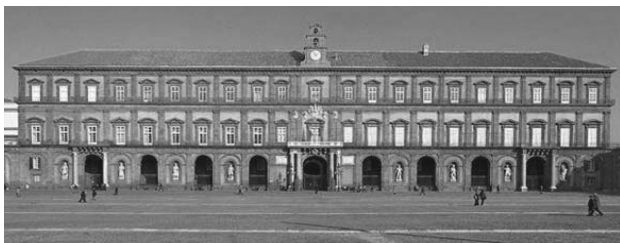
Figure 3. The Royal Palace of Napoli, built in the 17<sup>th</sup> century, whose façade was modified blinding some of the arches in the 18<sup>th</sup> century by architect Luigi Vanvitelli. Statues were added in the blinded arches in 1888.

Nice examples can be found in the past, as shown by the Royal Palace of Napoli (Figure 3), whose façade may appear homogeneous but underwent a number of modifications in a period of about three centuries, some of which were caused by static problems, or in the present, as shown for instance by the

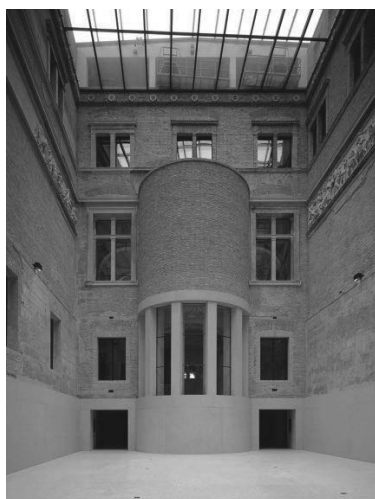
Figure 4. Neues Museum, Berlin, in which the restoration project by architect David Chipperfield has been carried out with new materials.

nice restoration of the Neues Museum in Berlin (Figure 4) with completely new and recognizable materials.

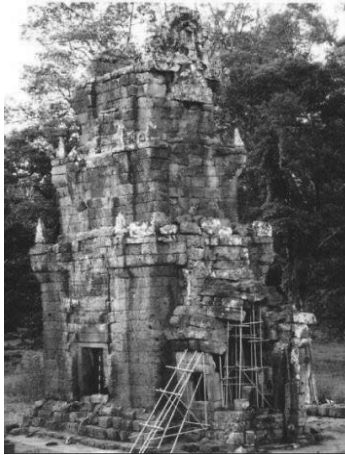
Figure 5. N1 tower in the Angkor ruins (Cambodia) before reconstruction (Akazawa et al. 2013).

The first, interesting case is presented by Akazawa *et al.* (2013), concerning the restoration of a tower (named N1, Figure 5) belonging to the Angkor ruins (Cambodia). The tower is a three story masonry structure made of laterite blocks, about  $10 \times 10 \text{ m}^2$  at the base and 20 m in height. The tower is founded on a 5 m thick mound of compacted sand, overlaying a natural formation made of silty sands with clayey layers. It has experienced in time large settlements, with the largest value of

about 40 cm measured on the side facing a nearby pond. The large structural damages, with wide cracks and a clear tilting of the structure towards the pond, were ascribed to a local bearing capacity failure of the wall facing the pond (Figure 6). As a consequence, it was decided to strengthen the compacted sandy foundation layer, mixing it with slaked lime and inserting layers of geotextiles, which was done completely dismantling the tower and reconstructing it after ground improvement completion. Even though this may seem an extremely invasive intervention and may pose problems in terms of the overall integrity and authenticity of the structure, it solved the static problems posed by the differential settlements experienced by the structure, which was on the verge of collapse.

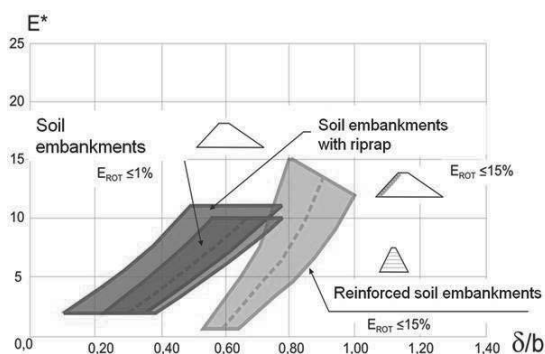
Figure 11. Summary of the results of the rock-fall experimental tests on small scale embankments (Hoffmann et al. 2013).  $E^*$  is a dimensionless energetic parameter defined by the authors as relative impact energy,  $\delta$  is the depth of penetration of the hitting sphere and  $b$  is the crest width (see Figure 10).

hitting rock block (or sphere, in the small scale experiments) to roll on or jump over the embankment crest, and also propose a simple design chart to estimate the penetration  $\delta$  into the embankment as a function of a non dimensional energetic parameter  $E^*$  (Figure 11).
