# Modern methods of geotechnical defense of buildings in the difficult geological conditions of Ukraine

Slyusarenko Y., Chervinskyy Y.  
*Research institute of building constructions, Kiev, Ukraine*

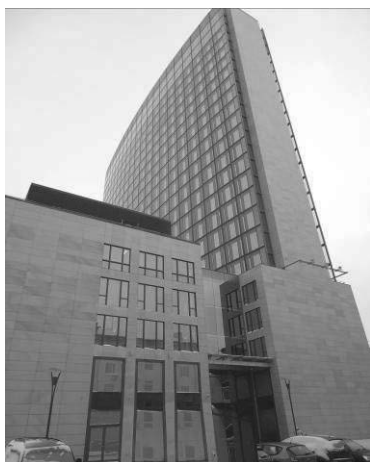
Fig. 1. General view of the «Pushkin» complex building.

The hotel complex «Pushkin» in Donetsk is built on territory, underworked by mining. The innovative decisions of geotechnical and structural defense of complex (the 5-storey underground parking under 24-storey building) are realized at planning, building and scientific accompaniment (Fig. 1, 2, 3).

The design decisions of building are accepted on a rigid structural concept both in parking and in above-ground part.

Foundation under building is designed as cast-in-place concrete slab of 2000 mm thickness. The columns of parking have the sections 600x600 and 600x1200 mm. Thickness of bearings walls is 600 mm.

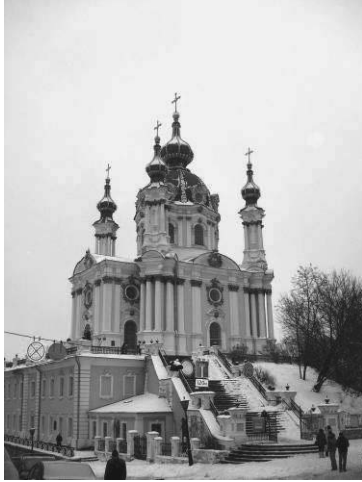
Fig. 9. The St. Andrew's church.

The St. Andrew's church is unique sight of history and architecture of 18<sup>th</sup> century, built in Kyiv on the design of the famous Italian architect F. Rastrelli. The church is built in baroque style, which formality, dynamic of architectural forms, riches of

decor, game of light and shade, is characteristic for. A church is erected on tailings of earthen fortress of 17<sup>th</sup> century. Building is crowned with the central dome and four angular decorative towers. Sizes of church are: length 32 m, width 20 m, height from a terrace to the top of cross of central dome 50 m.

Foundation is executed of masonry posts of 3 to 5 m width. The foundation base of the church beds on different marks: in western part – from 166,6 to 165,8 m; in east part which hangs over a hill – from 165,7 to 167,8 m.

It was discovered at the complex inspections of building, that it had substantial damages, main of them were through cracks, local destructions of clout layer and build solution of masonry. The uneven settling of basis, conditioned the presence of collapsible soils and slope slides appeared the principal reason of found out damages.
