Full-scale field validation of innovative dike monitoring systems

Koelewijn A.R., Vries (de) G.
Deltares

ABSTRACT: Three large scale field tests on dikes have been carried out at the IJkdijk test site in the Netherlands. Two tests involved piping, micro-instability of the sand core and erosion from overtopping. Both dikes failed on micro-instability. The third test involved slope stability with a deep sliding plane. All tests were done to validate monitoring systems and dike safety information systems. Several systems performed well.

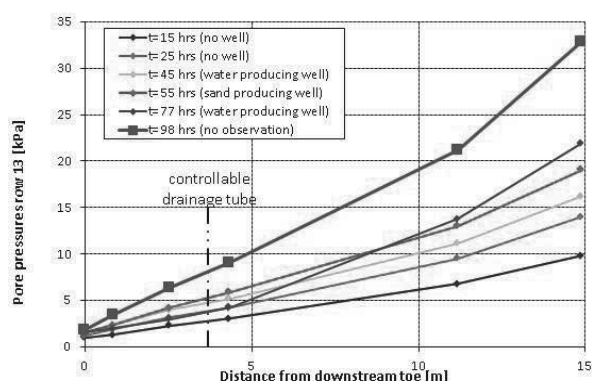
Figure 3. Pore pressures at sand/clay interface West

At 66.7 hours after the start of the test ($t=66.7$ hrs), at a head drop of 2.02m, the lower drainage tube was partly opened as piping had already been detected at the third line of pore pressure meters, i.e. upstream of this tube. This had a clear effect on the pore pressures, as shown in Figure 3, and the piping process stopped.

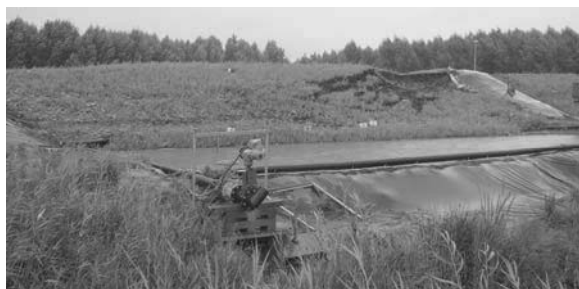
Figure 4. West dike close before failure.

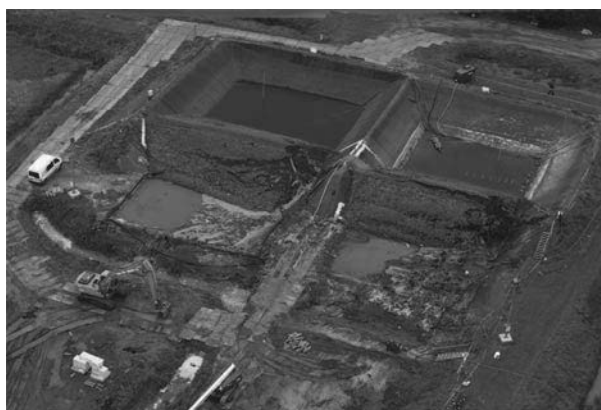
Figure 5. West and East dikes after failure.

As the last stages of the hydraulic load were delayed in comparison with the West dike, severe settlements from micro-instability of the sand core occurred later. Here at $t=138.9$ hrs (August 27th at 10:18 am) failure from micro-instability occurred. Figure 5 shows an overview of both failures.

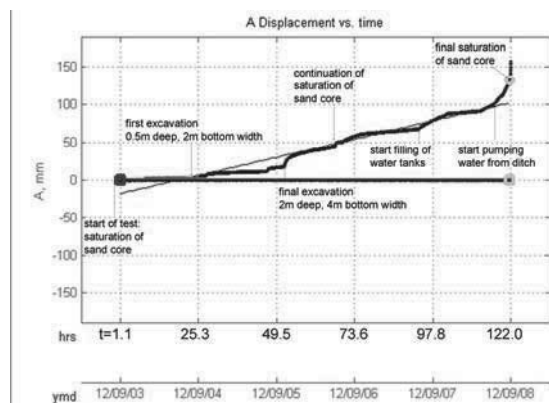
Figure 6. Horizontal displacements at toe of dike until close to failure.

by infiltration of water into the sand core. The next day, a small excavation was made in front of the dike. This had a limited effect on the dike, as shown in Figure 6 by the horizontal displacements at the toe of the dike. The next day, a final excavation was made and on the basis of slope stability calculations it was decided to continue by hydraulic loading only. In order to acquire a lot of measurement data, several days were taken to raise the phreatic surface in the sand core and to fill the water tanks on top. Finally, failure occurred on September 8th, at 2:27 pm, after 122.26 hours, see Figure 7.

Table 1 shows the results of slope stability calculations at characteristic moments applying the models of Bishop (1955) and Van (2001). The latter is a geometrically more flexible variant to Bishop's model. The results correspond well to the deformation behaviour shown in Figure 6: close to the critical value of 1, the deformations quickly increase. These results may even draw some suspicion, but it should be borne in mind that quite advanced soil investigations had been carried out prior to the test (Zwanenburg et al. 2011, Koelewijn and Bennett 2012) and detailed actual measurements of pore pressures were available. Moreover, the model by Bishop has already long ago been described as surprisingly accurate for conditions close to failure (Spencer 1967).

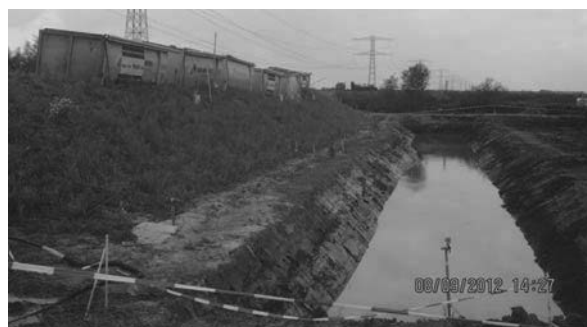
Figure 7. South dike during failure: fracturing of slope of ditch.
