Soil Properties of Liquefied Soils in Tokyo Bay Area by the 2011 Great East Japan Earthquake

Yasuda S.

Department of Civil and Environmental Engineering, Tokyo Denki University, JAPAN

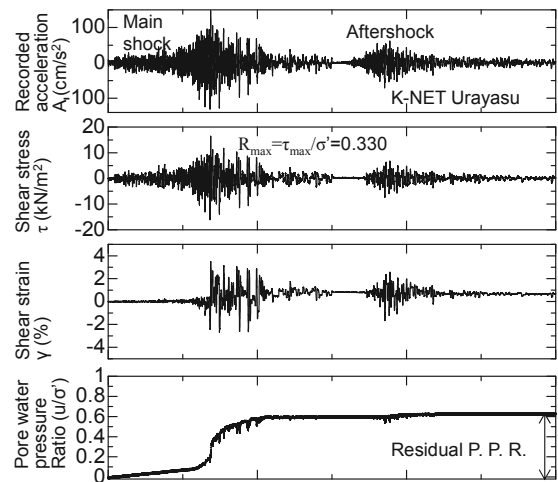
Silty sand taken from the boiled sand in Urayasu City was used for the cyclic torsional shear tests. The fines content, maximum void ratio and minimum void ratio were 36%, 1.477 and 0.828, respectively. The silty sand was poured into a mold with a relative density of 90 %. Two types of shear wave were applied to the specimen, a sine wave of 20 cycles and the seismic wave recorded during the main shock and the aftershock at the K-NET Urayasu site. In the case of seismic wave, excess pore water pressure increased gradually with shear stress as illustrated in Figure 4. The relationships between the stress ratio R (τ_d/σ') for the sine wave or R_{max} (τ_{max}/σ') for the seismic wave and residual excess pore water pressure u/σ_c' are plotted in Figure 5. As $R=0.27$ for $u/\sigma_c'=1.0$ and $R_{max}=0.31$ for $u/\sigma_c'=1.0$, the correction factor C_w according to the JRA standard (JRA, 1996) becomes 0.82. The safety factor against liquefaction F_L and the liquefaction potential P_L were evaluated from the data gathered from boring sites along the 11 soil cross sections shown in Figure 1, under the conditions of $C_w=0.82$ and 1.0. In the estimation, R_L was estimated from SPT N -values and fines content F_c , using the formula proposed by the technical committee of Urayasu City (Urayasu City, 2012). Figure 6 shows the F_L values evaluated from boring data from Urayasu, where liquefaction occurred. If the C_w is assumed be 1.0, most of F_L are estimated to be greater than 1.0, whereas F_L are less than 1.0) if C_w is assumed to be 0.82. Figure 7 compares

Figure 4 Time histories of shear stress, shear strain and excess pore water pressure

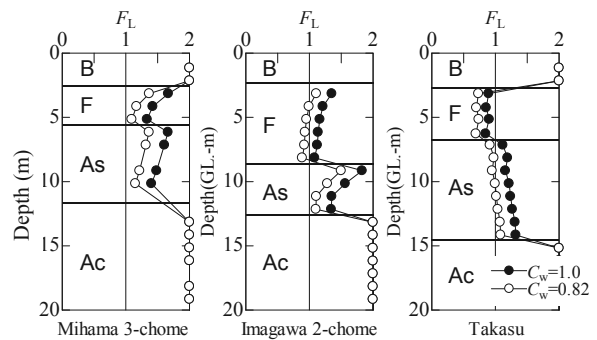
Figure 6 Analyzed F_L at liquefied sites in Urayasu City

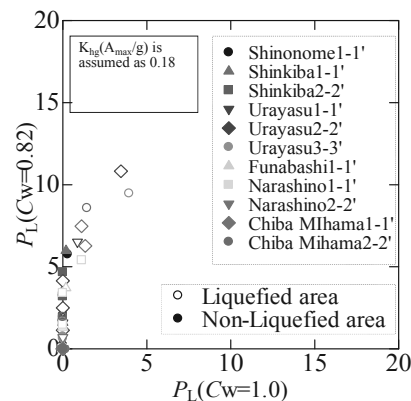
Figure 7 Effect of C_w on P_L

P_L for all boring data under the assumption of $C_w=0.82$ and $C_w=1.0$. If $C_w=0.82$, P_L for liquefied sites are calculated to be greater than about 10 and the severity of liquefaction can be demonstrated.

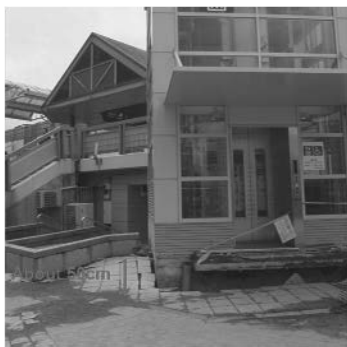
Much eruption of sands and large ground subsidence occurred in the liquefied area. The maximum thickness of the erupted sand and the maximum ground subsidence observed by the author were about 30 cm and 50 cm, respectively, as shown in Figure 8. This was the first time the author had seen such thickly deposited boiled sand in Japan. However, much eruption and large subsidence also occurred in Christchurch, New Zealand during the main shock in September 2010 and the aftershock in February 2011. Erupted sands in Christchurch and

Figure 8. Large settlement induced at Shin-urayasu station

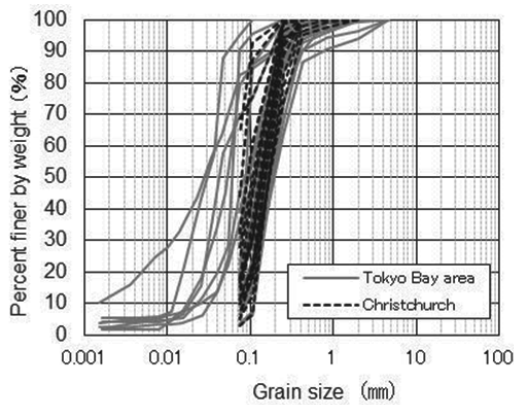
Figure 9. Grain size distribution curves of boiled sands in Tokyo Bay area and Christchurch

Tokyo Bay were silty sands or sandy silts with much fines, as shown in Figures 9. A model test was carried out to demonstrate how very fine sandy soils cause much eruption and large ground subsidence.

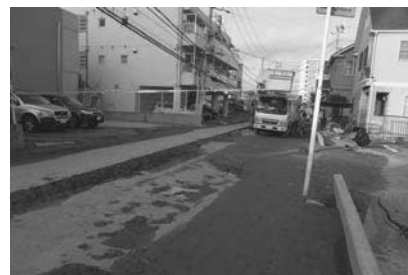
Strange heaving, buckling or thrust was observed at several footways and alleys, as shown in Figure 12. Some boundaries existed besides the footways and alleys, such as banks of old sea walls and elevated bridges. Therefore, some thrust might have occurred at these boundaries due to a kind of sloshing of liquefied ground, as schematically shown in Figure 13 (1), because shaking continued for long time after the occurrence of liquefaction, as mentioned above. On the other hand, the heaving of a footway was observed even though there was no such boundary as shown in Figure 12. The locations of heaved footways and alleys in Urayasu City, with and without

Figure 12. Thrust of an alley in Urayasu City
