# The design and construction of temporary works for Limerick Immersed Tube Tunnel

Smith A. K. C.  
*Coffey Geotechnics Ltd.*

Thorup O.  
*John Sisk & Son Ltd.*

Hudson J.  
*Haydn Evans Consulting, formerly MLM Consulting Ltd.*

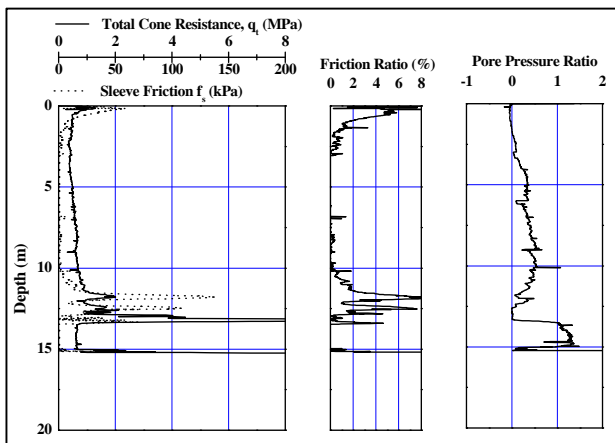
Figure 3. Typical static cone test profile

The properties of the alluvial clay dominated the design of the tunnel. They were investigated primarily using static cone penetration tests (CPTs). Figure 3 shows a typical CPT profile. There is a thin crust, below which the strength decreases, then gradually increases again with depth. Between 11.5 and 13.5 m the end resistance increases significantly, and this layer is believed to be a paleo-surface which at some time has dried out. Below it, the cone resistance decreases substantially. Over much of the depth of the clay, the sleeve friction is zero. This is believed to result from the very sensitive nature of the clay, which liquefies as it is penetrated by the cone, so the friction sleeve measures no strength. The measured pore pressures were correspondingly very high.

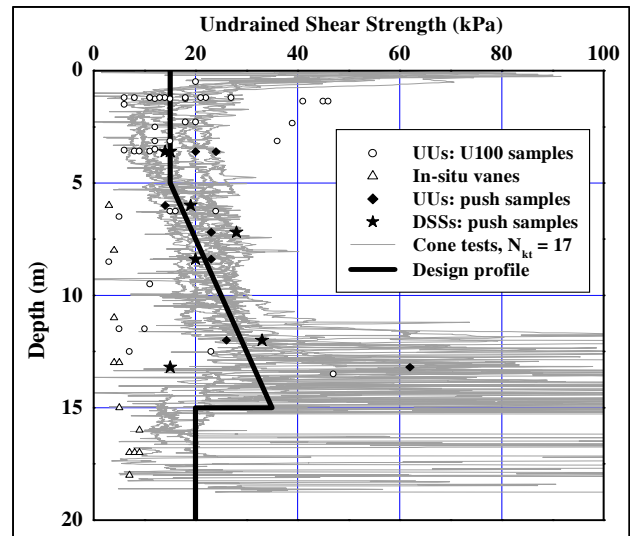
Figure 4. Undrained shear strength results for alluvial clay

Figure 4 shows a composite plot of cone resistance, plotted as interpreted undrained shear strength, together with the design profile adopted and results from undrained triaxial tests on U100 samples and from vane tests carried out in boreholes. Both the triaxial tests and the vane tests gave much lower values than the cone tests. It was believed that the very sensitive nature of the clay led both to sample disturbance and to disturbance below the base of the borehole. In order to verify the design profile, high-quality “Mostap” push samples were taken using the cone equipment, and subjected to unconsolidated undrained and direct simple shear tests. These gave values straddling the design profile from the cone tests, and hence gave additional confidence in its use. Buggy and Peters (2007) derived a very similar shear strength profile for the approach roads to the tunnel.

It may be noted that the design shear strength profile corresponds to a value of the ratio  $s_u/\sigma_v'$  of between 0.30 and 0.35. This is comparatively high for a normally consolidated clay. Two cone tests were carried out from the top of the flood levees, where the value of  $\sigma_v'$  would be expected to be 80 to 100 kPa greater, but to have been applied for a comparatively short period. These gave higher shear strengths, but a lower value of  $s_u/\sigma_v'$  of 0.24, consistent with what would be expected for normally consolidated clay. It is therefore believed that the high strength ratio of the clay results from some form of aging.

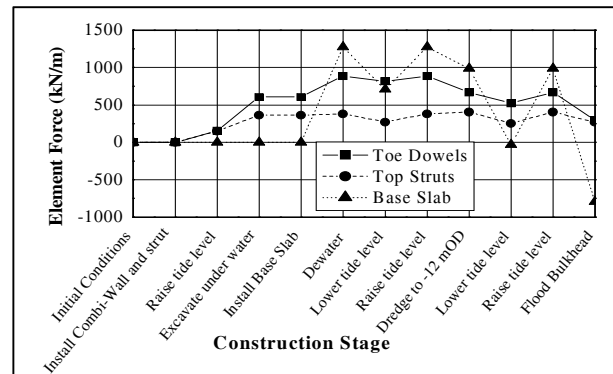
Figure 7. Calculated forces in structural elements

structural element forces in different wall sections were then passed to the structural engineers in both tables and graphs. Thus, for example, Figure 7 shows the forces in the dowels, struts and base slab restraining the bulkhead. The large effect of the tides, particularly on the base slab, is very evident. This added further complexity to the analysis, since it was necessary to consider the effects of construction stages being carried out at different stages of the tide. Thus one of the most difficult and important aspects of the design was, not so much the analyses themselves, as keeping track of the different cases that had been analysed, and checking that all cases had been considered.
