**APPLICATION OF  
THE OBSERVATIONAL METHOD  
AT KINGS PLACE  
LONDON**

## **OM at Kings Place**

# 16m deep basement construction

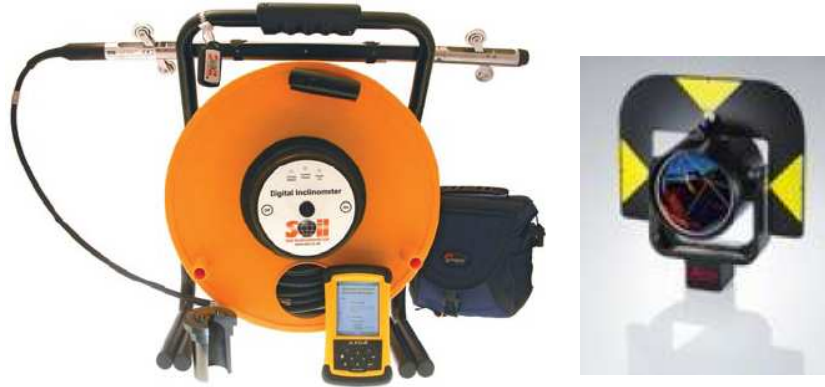
## Primary monitoring

- Inclinometers
- Prisms
- Strain gauges
- Survey points
- Piezometers
- Tilt meters

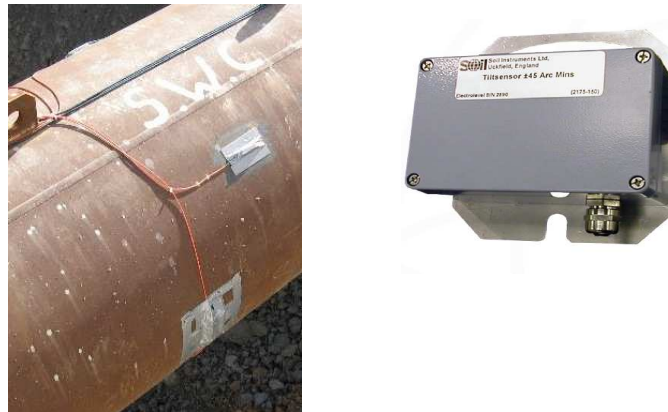
## Secondary system

- Reflector targets
- Prisms
- Survey points
