# Investigation of Reinforced Earth Structures Following the 2011 Tohoku Earthquake

Otani Y., Takao K.  
Hirose & co., Ltd.

**ABSTRACT:** An investigation of mechanically stabilized earth (MSE) structures constructed with Reinforced Earth (Terre Armée) technology<sup>1</sup> was carried out after the 2011 Tohoku Earthquake in Japan. Reinforced Earth walls examined for the survey were ranked according to associated disaster-caused damages. The results of this research indicated high levels of earthquake resistance in the steel-reinforced structures constructed with this technology method.

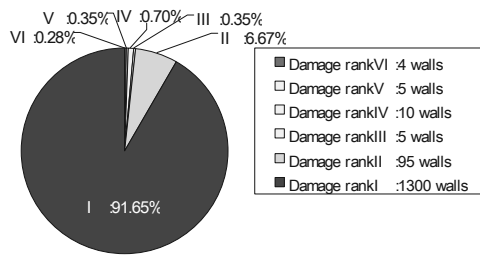
The Tohoku Earthquake that took place on March 11, 2011 was a reverse fault type earthquake with its epicenter in an ocean trench at the boundary of the Pacific Plate and North American Plate. It registered a moment magnitude ( $M_w$ ) of 9.0 and a seismic intensity of 7.0, the maximum intensity on the JMA scale ( $MM \text{ scale} \approx 5.5 \cdot \text{JMA scale} + 0.5$ ). The earthquake generated tsunami waves that affected not only Japan, but also other Pacific Rim countries, with the height of tsunami waves travelling upstream and over land reaching as high as 40.1 meters. In addition, the earthquake caused landslides, liquefaction and subsidence. During the one-month period after the earthquake, over 100 aftershocks registering intensity of 4.0 or greater on the Japanese scale occurred. Figure 1 shows the distribution of Reinforced Earth walls that were classified as Damage Rank II or higher. In Figure 2, a pie chart of the Reinforced Earth wall numbers by Damage Rank is provided for 1,419 of the structures. The walls in the figure represent 55% of the 2,540 such walls subjected to upper intensity 5 or higher tremors. It is noted that a total of 4,127 Reinforced Earth walls were located in what was considered the overall disaster stricken area<sup>3</sup>. Of the 1,419 walls surveyed, 1,400

(approximately 98.4%) had non-existent to light damage (Damage Rank I or II). Only 4 walls (0.28%) rated Damage

Figure 2. Percentages of each Damage Rank

Rank VI, meaning damage was so severe that they were no longer functional; including one wall in a construction site where measures to counter frost heave were being implemented before putting the wall into service.
