The Challenge of the Slope Failure Problem and Its Remedial Considerations at Mileage 39km, Mt. Ali Road, Taiwan

Chang M., Huang R.
National Yunlin University of Sci. & Tech., Taiwan

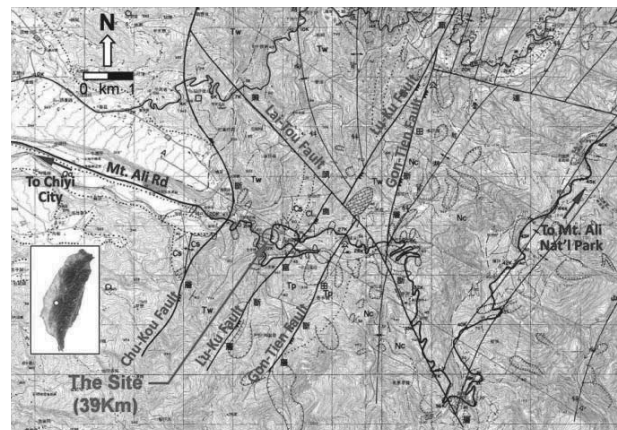
Figure 1. Regional geology of the area (Liu & Tseng 2000).

- A complex geologic structure at the site (Figure 1) where the underlying geologic units are generally fractured.
- The 1999 earthquake shaking that had weakened underlying geologic structure and enhanced deterioration process of the materials.
- The steep downhill slope geometry (60° angle & 200m deep).

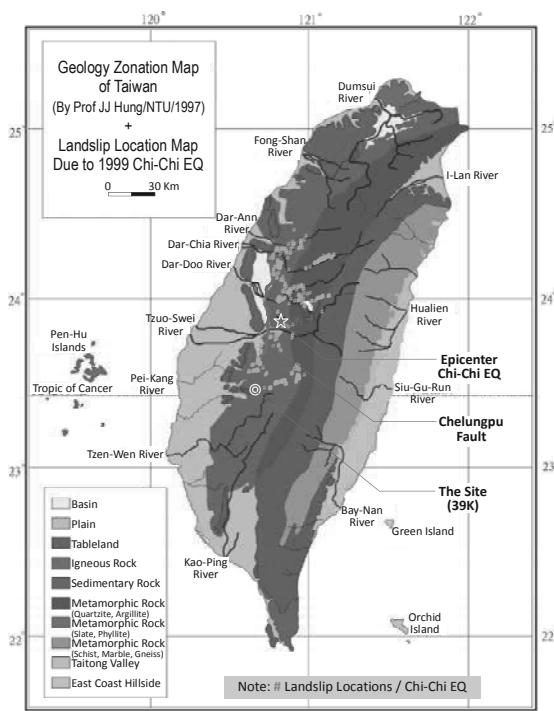
On September 21, 1999, a severe earthquake (Chi-Chi, $M_w = 7.6$) hit central Taiwan and caused numerous landslips or slope failures in the mountain range of the island, as indicated in Figure 3. Based on studies by National Center for Researches on Earthquake Engineering (NCREE 2000), approximately 1500-2000 landslides were directly induced by the earthquake. Although the shaking did not have immediate impacts at the site, the condition of the road and its adjacent side slopes appears to be deteriorating.

Figure 3. Locations of landslides due to Chi-Chi EQ (NCKU 2000).
