The December 29th 2010 Xerolakka Municipal Solid Waste landfill failure

Athanasopoulos G., Vlachakis V.
Dept. of Civil Engineering, University of Patras, Greece

ABSTRACT: On December 29th 2010, a 30 m high slope failed at the Xerolakka Municipal Solid Waste landfill in Greece. The failure resulted in temporary interruption of the landfill disposal activities and closure of the landfill access road; it also received significant media attention. A reconnaissance of the landfill slope instability was performed a few hours after the failure. Subsequent data collection, field investigations and numerical analyses were performed to better characterize the causes of the instability. Data collection included review of available data regarding the landfill design and the waste material at the Xerolakka landfill. Field investigations included Lidar surveying to closely map the post-failure geometry, as well as shear wave velocity measurements that were used as a basis for characterization of the MSW material and comparison with data available in the literature. Numerical analyses included limit equilibrium as well as finite element analyses. The results of the investigation indicate that t

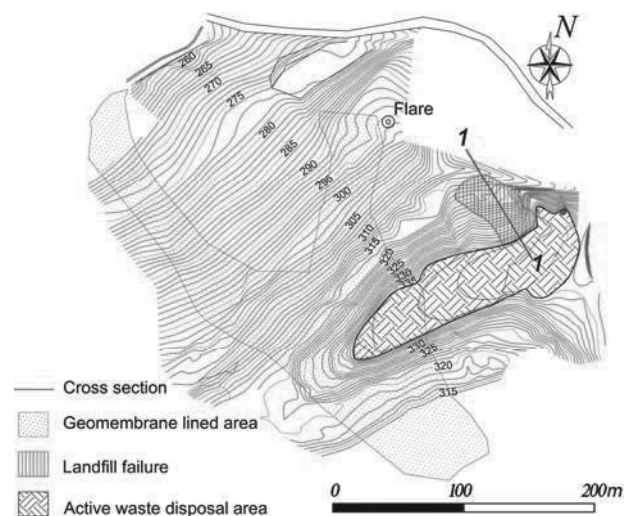
Figure 1. February 2011 topographic map of the Xerolakka canyon landfill.

A topographic map of the landfill is shown in Fig. 1. The first cell of the landfill was geomembrane-lined. Subsequently the use of geosynthetics was discontinued because of the presence of impermeable geologic formations (Seisakis and Roussos, 1994). Due to strong public opposition, new cells were not constructed, as anticipated in design. In the absence of an alternative waste management solution, the landfill continued to receive waste. Thus, a waste mound with increasing height and slope inclination was formed (shown in the southeast side of Fig. 1) which partially failed on December 29th 2010.
