# The interaction of normal fault ruptures and shallow foundations: (failles normale et fondations) **Centrifuge modelling**

Fraser Bransby, Ala'a El Nahas, Shuichi Nagaoka, Michael Davies  
The University of Dundee

# 1. Centrifuge modelling:

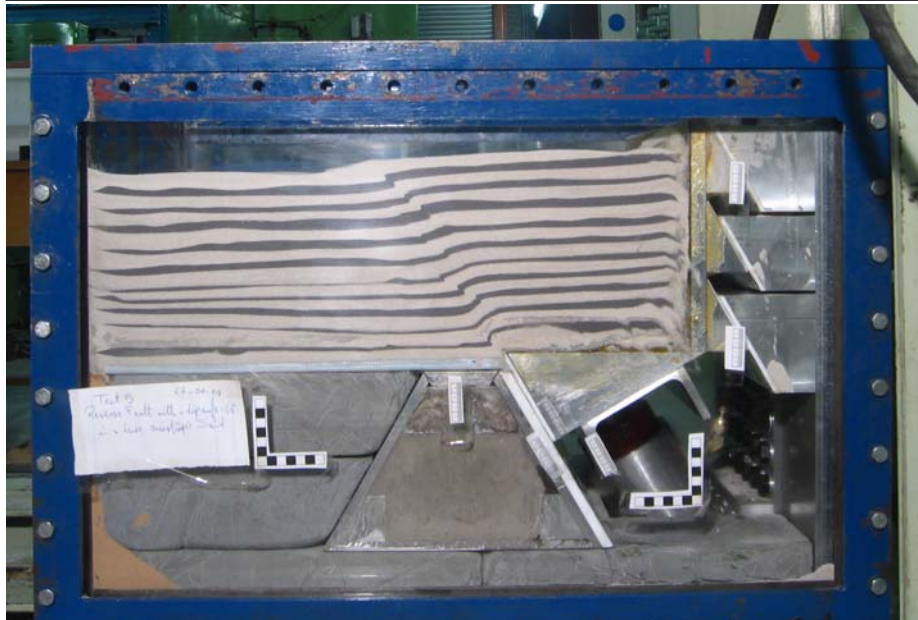
- Accelerated to 115 g in centrifuge to produce same  $\sigma'$  as for 25 m soil depth.

- Allows well controlled and instrumented tests

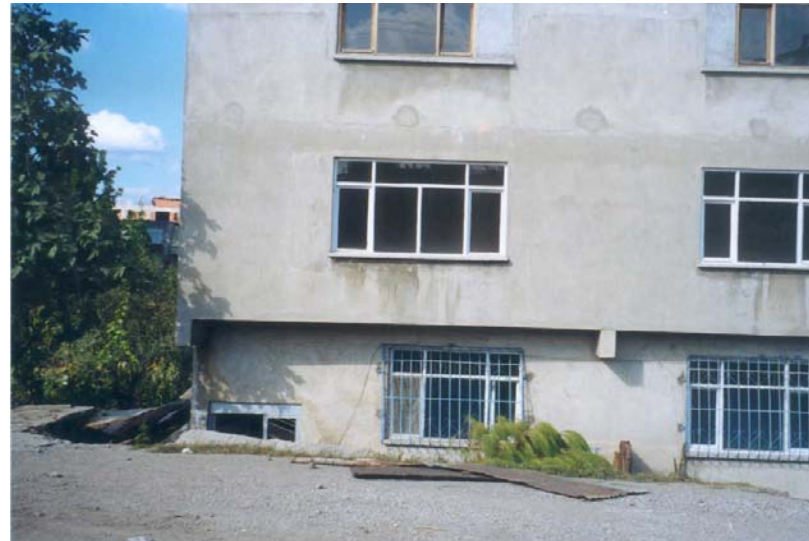
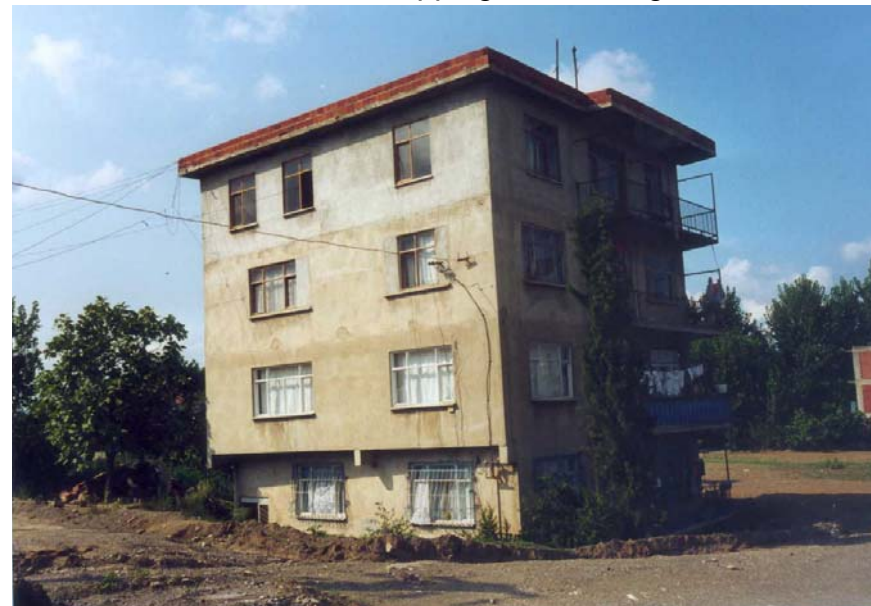
The results may explain this behaviour in Golcuck:

– possible fault deviation

Building 1 : 4 storeys + Basement – No Damage

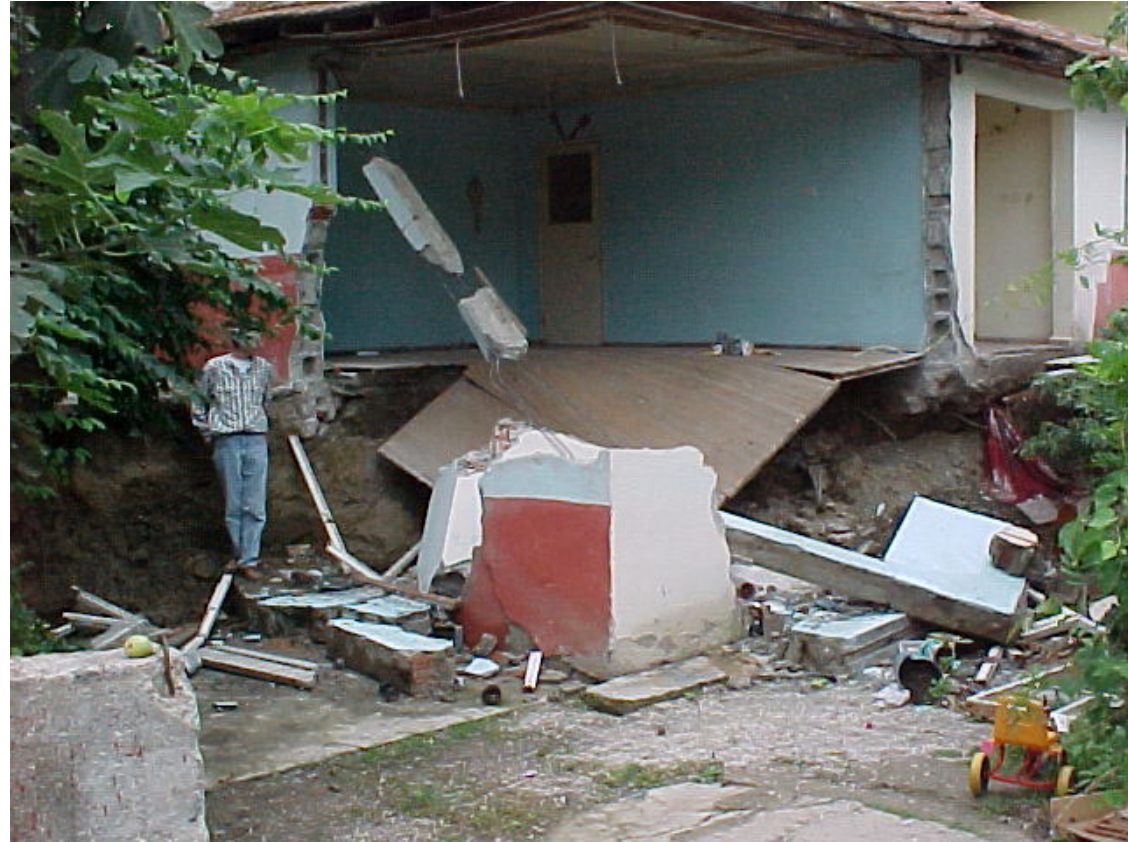
The results may explain this behaviour in Golcuck:

- No fault deviation

Building 2 : 1 storey – partial collapse
