Response of piled buildings to deep excavations in soft soils

Korff M.

Mair R.J.

ABSTRACT: This paper explores the building displacements related to deep excavations for a case study from the Netherlands: the construction of the North South Metro Line in Amsterdam. The overall goal of the analysis of the displacement is to study the interaction of deep excavations with piled buildings. The response of buildings is governed by the soil displacements resulting from the excavation. These displacements are described in a second, related paper in this conference. In this paper, the response of the piled buildings is described.

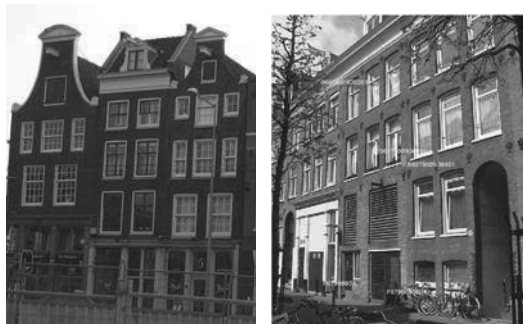
Figure 2 Historic buildings at Vijzelgracht (left) and Ceintuurbaan Station (right), dated 1880-1920

Most buildings in the historic centre of Amsterdam are built with masonry walls, wooden floors and timber pile foundations, the piles being founded in the First Sand Layer at about 12m below the surface level (see Figure 1). More recent buildings with 1-4 storeys are built with concrete walls and floors and prefabricated concrete or steel piles. Foundations for some recent buildings are in deeper layers such as the second sand layer. The buildings considered in this paper are from the older type, see Figure 2.

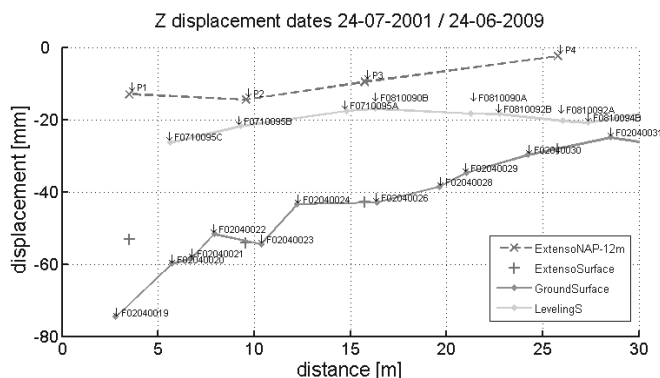
Figure 8 Ground and building displacements for CS13110 (at Ceintuurbaan) in the period 2001-2009

For a second series of buildings with more modern foundations (old timber piles combined with renovation steel piles), the depth at which the pile and soil settlement are equal is found at approximately 0.8 – 1.0 times the pile length, see Figure 8.
